**AN ARCHAEOLOGICAL INVESTIGATION OF THE
SOUTH PORTICO AT GERRARD HALL ON THE
UNIVERSITY OF NORTH CAROLINA
AT CHAPEL HILL CAMPUS**

R. P. Stephen Davis, Jr.
and
Brett H. Riggs

Research Report No. 24
Research Laboratories of Archaeology
University of North Carolina at Chapel Hill

February 2006

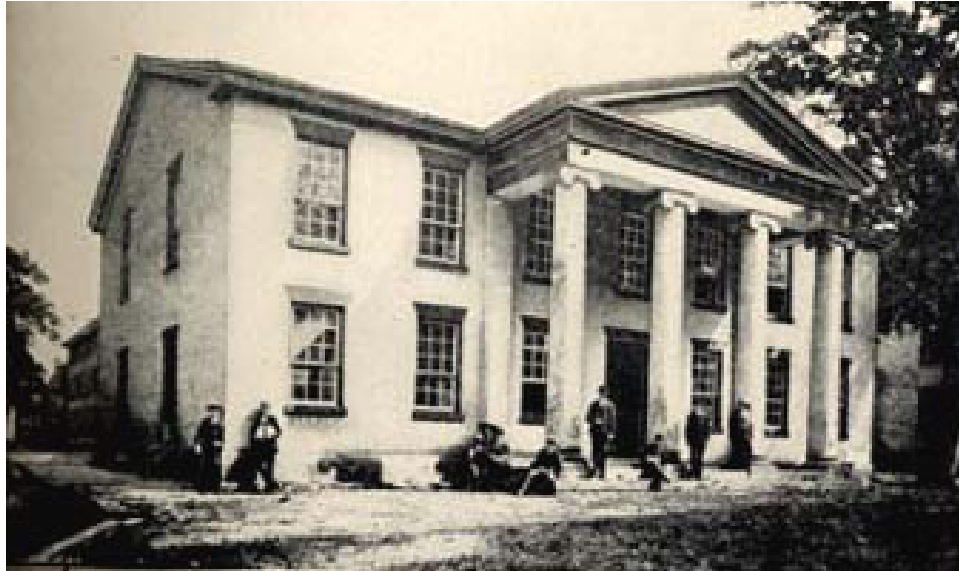
Figure 3. View of Gerrard Hall in the late 1800s, before removal of the south portico (from Battle 1907:280). Note the central doorway beneath the portico. View to the northeast.

supported by four large Ionic columns, was located about 3.26 m (10.7 ft) from the building's south wall (see Figures 3 and 4).

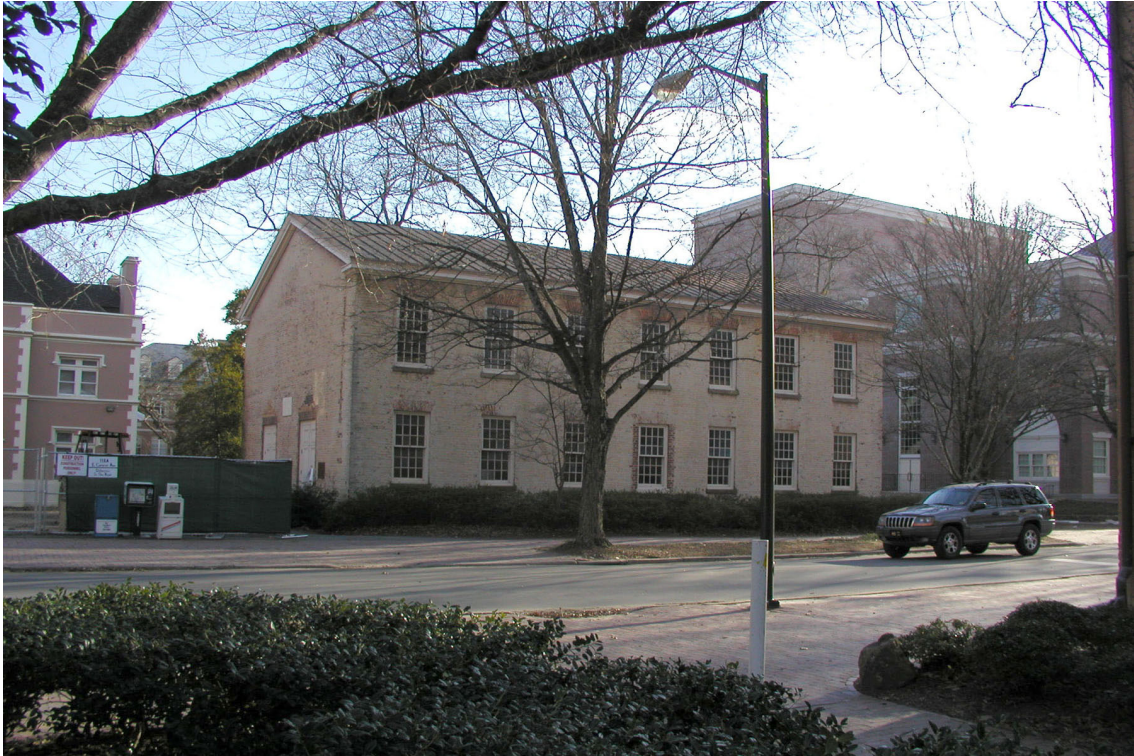
Figure 5. View of the north side of Gerrard Hall looking across Cameron Avenue.

Today, Gerrard Hall is a small, plain, two-story brick building measuring 66.2 ft by 45.1 ft (20.2 m by 13.8 m), and it rests on a foundation of dressed stones set in a builder’s trench (Figures 5 and 6). Consequently, it was assumed that the portico was similarly constructed and that the basal members of that foundation should have survived any subsequent ground disturbances. Given Gerrard Hall’s age and location near the heart of the original campus, it was expected that an excavation would yield artifacts from the earliest years of the university and could provide insights into the life of the university community at that time.

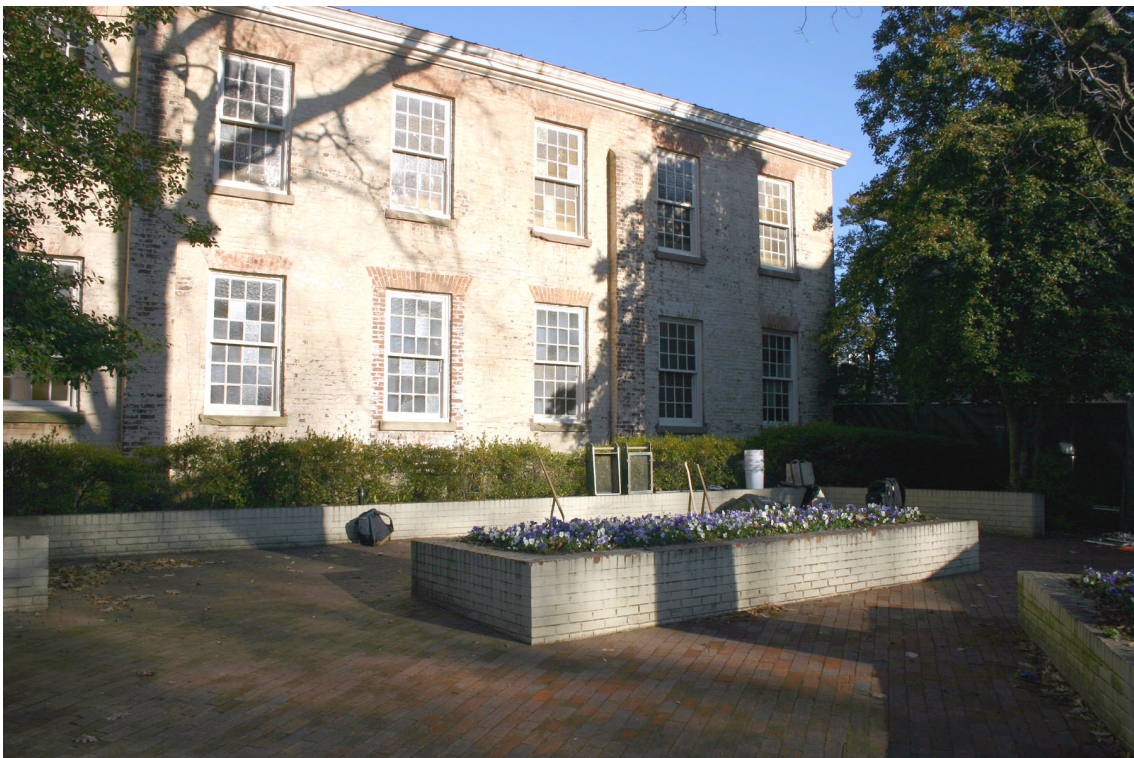
Figure 6. View of south side of Gerrard Hall where the portico once stood. Note the brick pilasters. The area of excavation is between the building and the low brick wall.

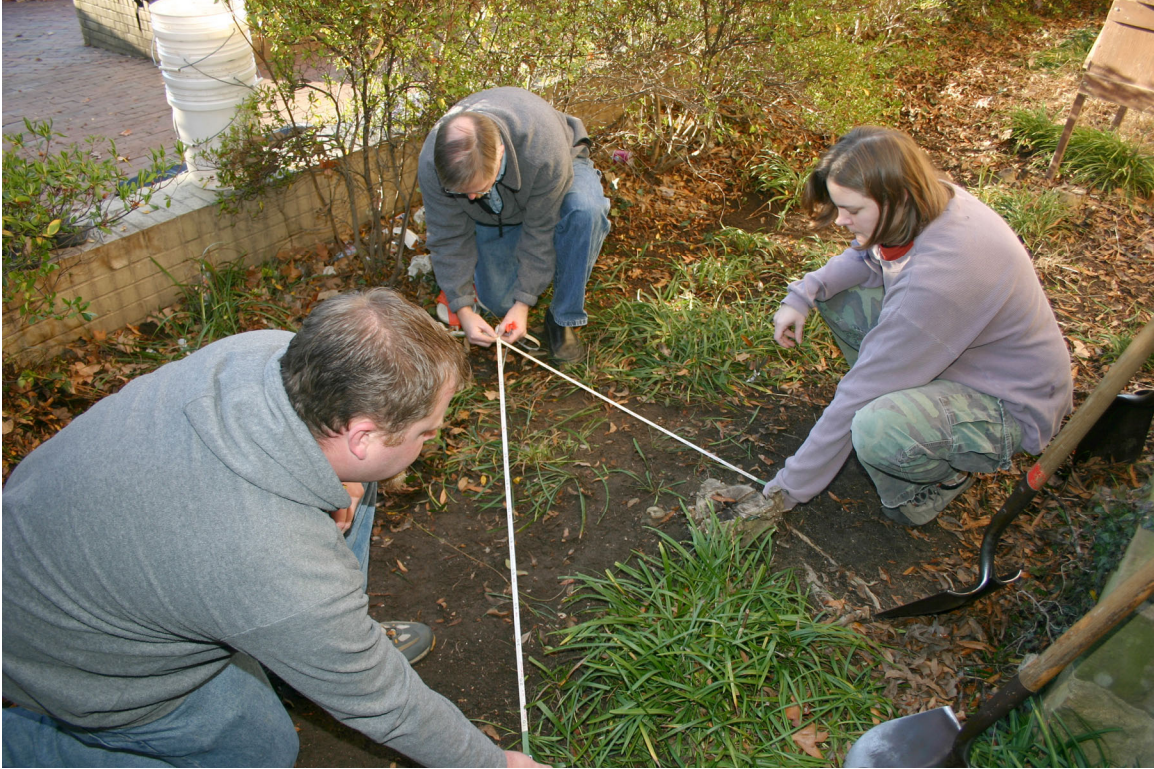
Figure 7. Laying out the first excavation units at Gerrard Hall.

Prior to excavation, a grid of one-meter squares was laid out along the south wall of Gerrard Hall (Figure 7). This defined a 10 m (east–west) by 3 m (north–south) area containing 30 potential one-meter excavation units. A reference point located one meter south and one meter east of the east pilaster was assigned a grid coordinate of 100R100 and another reference point was placed 10 m to the west, and just southwest of the west pilaster, at 100R90. Both reference points, as well as all excavation unit corners, were marked with steel gutter spikes. All horizontal and vertical controls were maintained

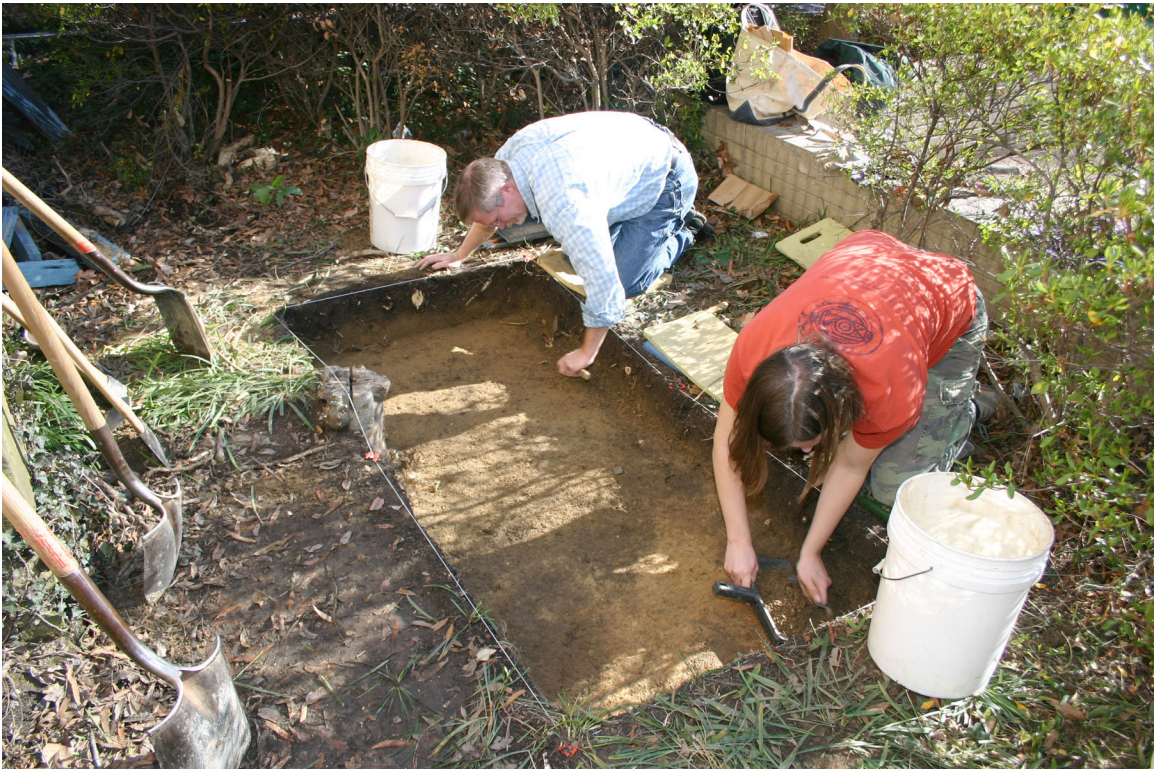
Figure 8. Cleaning Squares 99R99 and 99R100 at the base of Level 2. View to southeast.

Based upon the preliminary investigation of the project area, the first two excavation units were laid out over the east edge of the original portico (Squares 99R99 and 99R100). These units were excavated simultaneously by natural level and all excavated soil was dry-screened through ¼-inch mesh to retrieve artifacts (Figure 8).

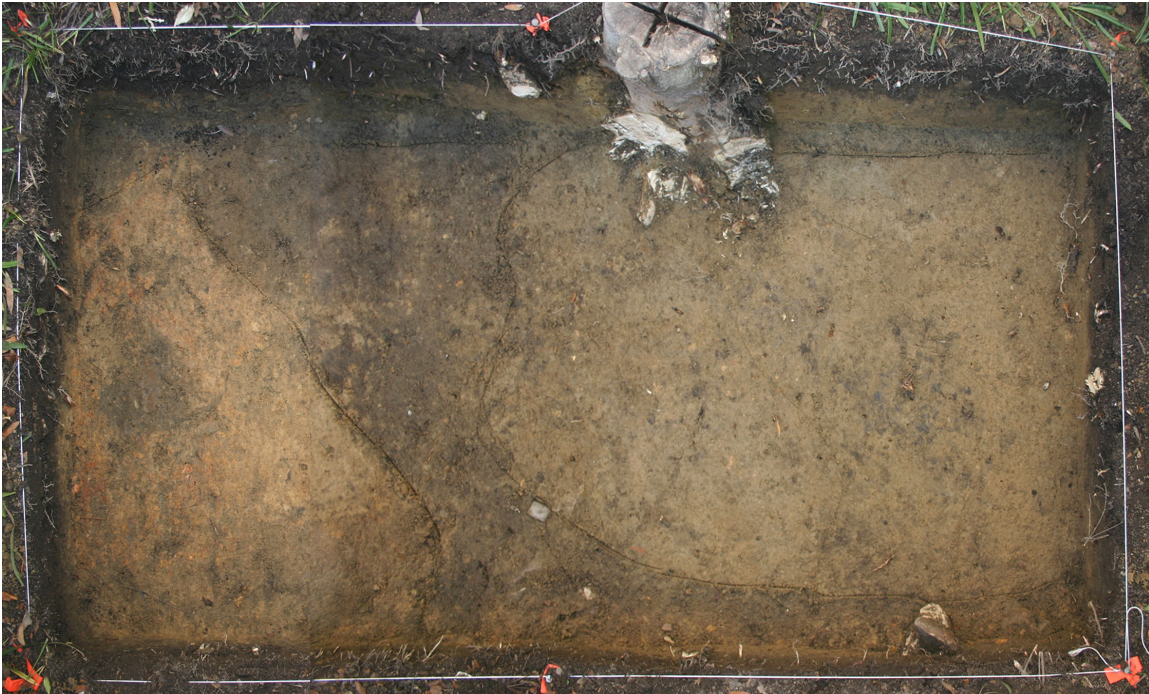
Figure 9. Photographic mosaic of Squares 99R99 and 99R100 at the base of Level 2. North is to the top of photo. Excavation measures 1 m (east-west) by 2 m (north-south).

At the base of Level 1, the soil abruptly changed to a mottled yellowish brown sand that was designated Level 2. It was 8–14 cm thick and contained a brass screw, two cut nails, seven wire nails, 85 window glass fragments, 17 bottle fragments, 1 whiteware sherd, 2 stoneware sherds, two coal fragments, and five small brick fragments. As with the soil in Level 1, this soil represents recently deposited fill. At the south edge of both excavation units, it capped the top of a utility trench containing telephone lines (Figures 9 and 10).

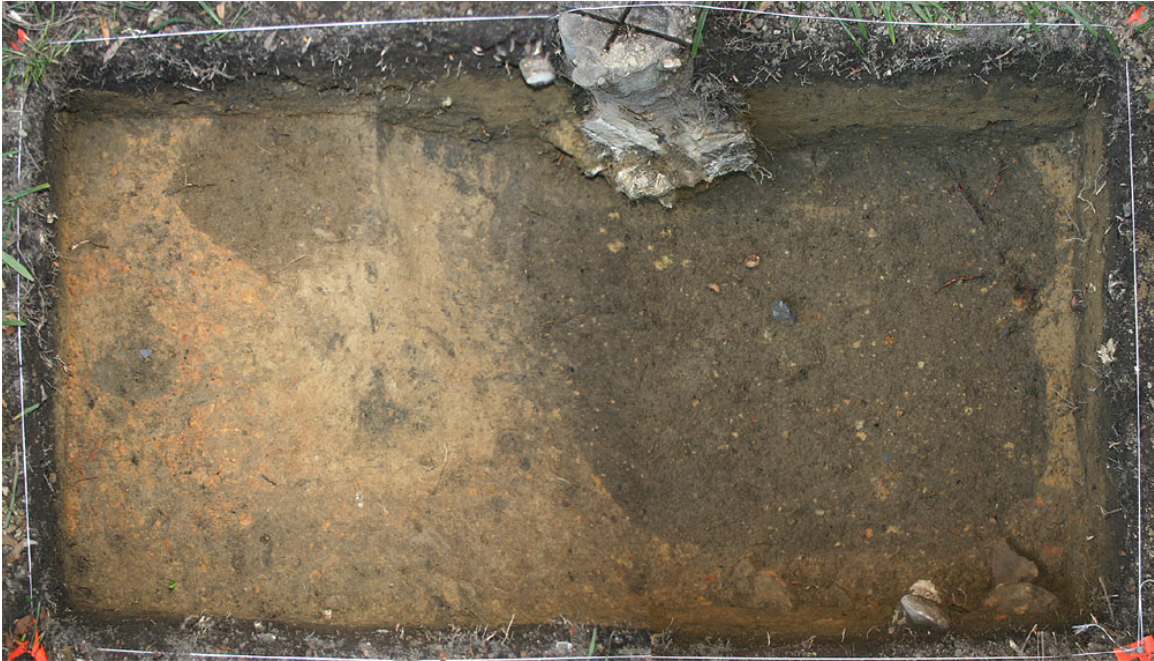
Figure 11. Photographic mosaic of Squares 99R99 and 99R100 after removing Zones 1 and 2 of Feature 1. North is to the top of photo. Excavation measures 1 m (east-west) by 2 m (north-south).

The edges of Feature 1 at the base of Zone 2 were distinct, and the south edge intruded the trench containing telephone lines at the south edge of Sq. 99R100. Both characteristics, as well as the artifact content of Zone 2, indicate that Feature 1 was a modern disturbance. Zone 3 was augered to a depth of about 50 cm without hitting the bottom, so it was decided not to excavate this feature any further (Figures 11 and 12).

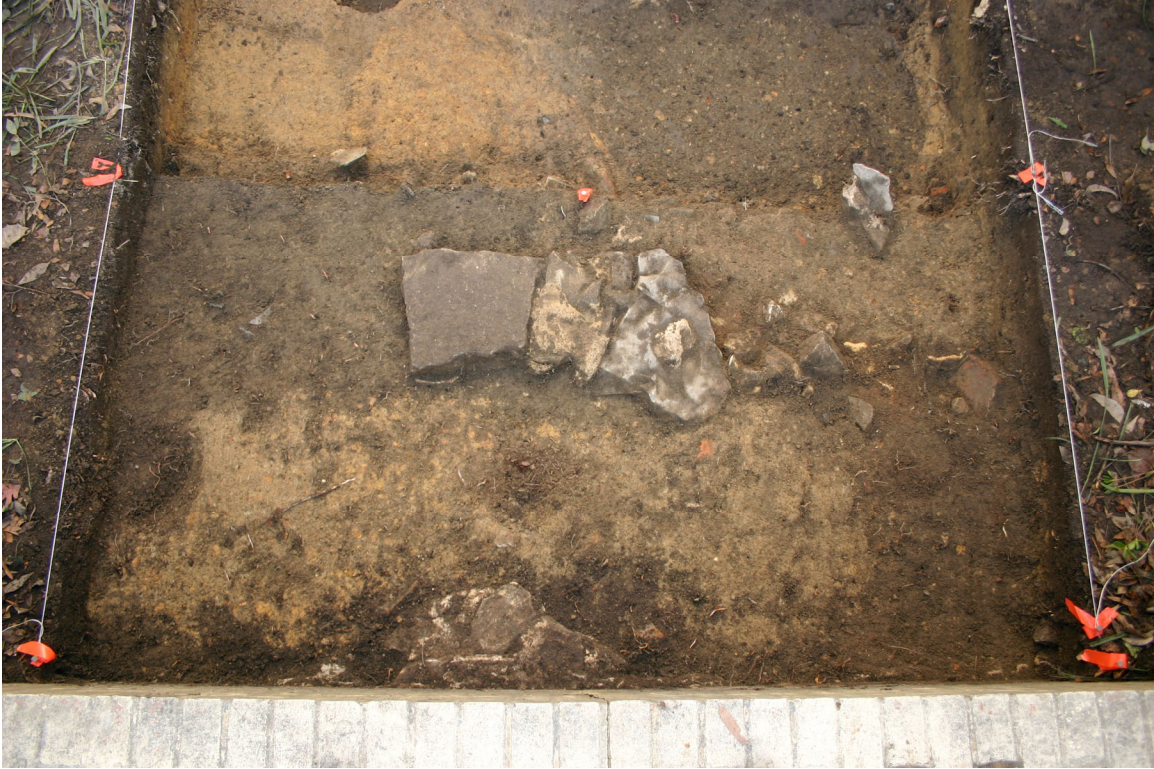
Figure 13. Top of foundation partially exposed in Squares 98R99 and 98R100. View to north.

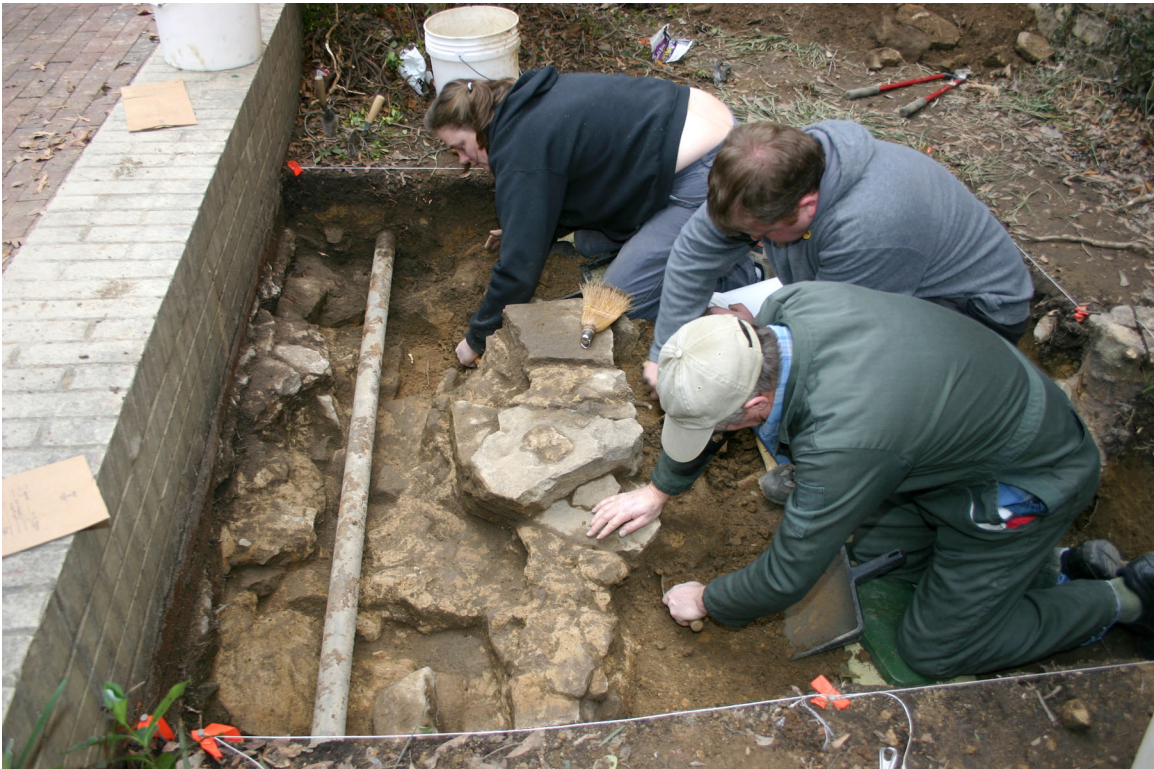
Figure 14. Excavating around the foundation in Squares 98R99 and 98R100. View to west.

The remaining disturbed fill overlying the foundation was then removed with shovels and trowels (Figure 14). This soil was not screened. While the upper surface of the foundation was very irregular due to intrusive disturbances, all basal members were present, so that a complete outline of the foundation's north edge and east end could be determined. It was not possible to determine the south edge because the foundation extended beneath the low brick wall at the edge of the shrubbery bed. Where the upper stones had been removed, the stone surfaces beneath them were covered with a lime-and-sand mortar. This mortar also was observed in all visible joints between foundation stones. Other loose stones flanked the north edge of the foundation and provide a suggestive outline for a builder's trench; however, the fill beneath them was uniform and no trench edge could be identified (Figures 15 and 16).

top of the foundation was largely missing, the flat, mortared stones at the east end of the foundation (beneath the east corner column) may represent a surface upon which dressed stone blocks were placed (see Figures 13 and 14). This stone surface was encountered less than 20 cm (0.66 ft) below the present ground surface.

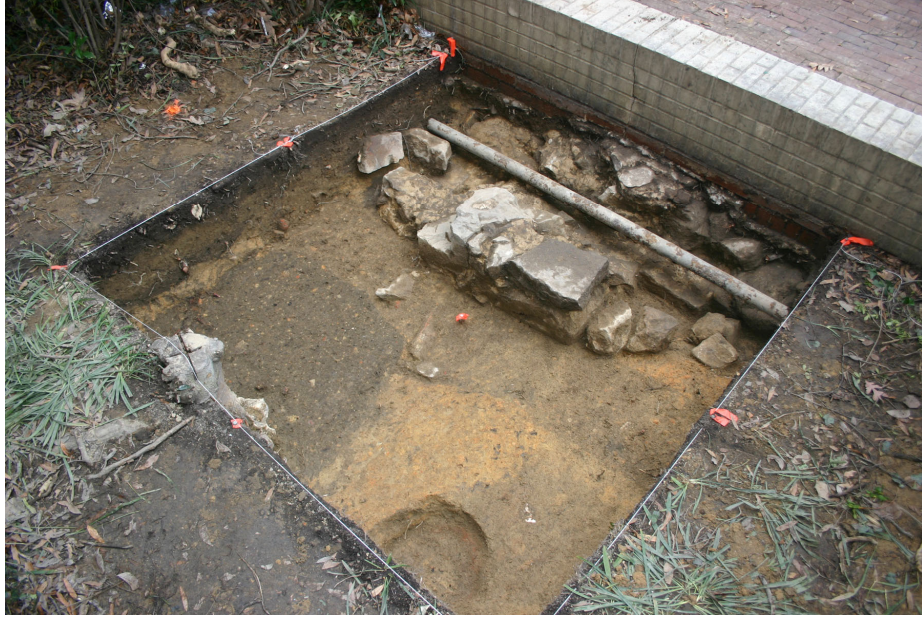
Figure 15. Squares 98R99, 98R100, 99R99, and 99R100 with foundation exposed. View to southeast.

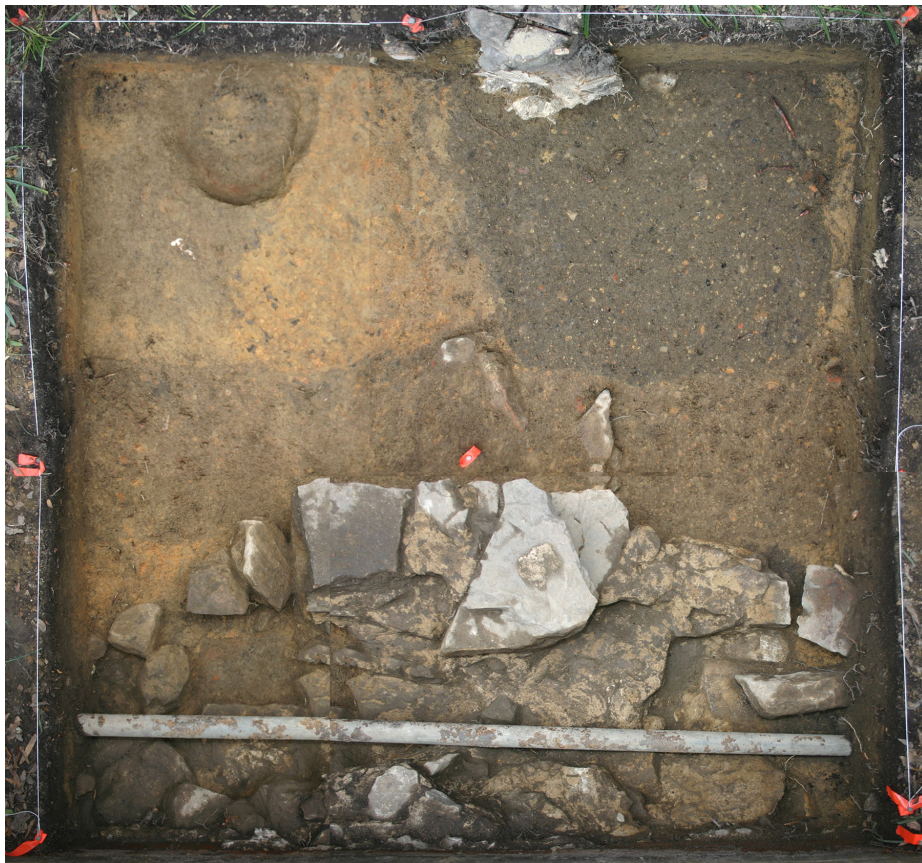
Figure 16. Photographic mosaic of Squares 98R99, 98R100, 99R99, and 99R100 after exposing the top of the portico foundation. North is to the top of photo. Excavation measures 2 m (east-west) by 2 m (north-south).

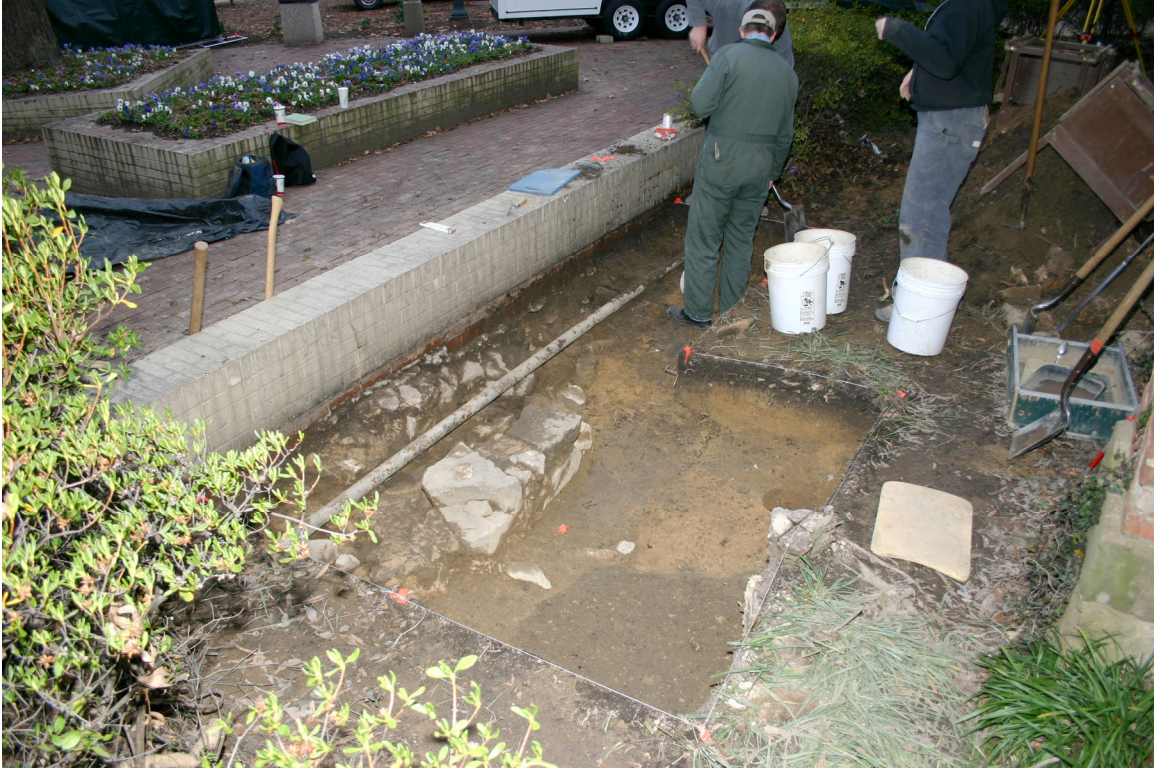
Figure 17. Expanding the excavation to the west to expose the portico foundation. Note that the low brick wall flanking the brick patio to the south was built upon the old foundation. View to southwest.

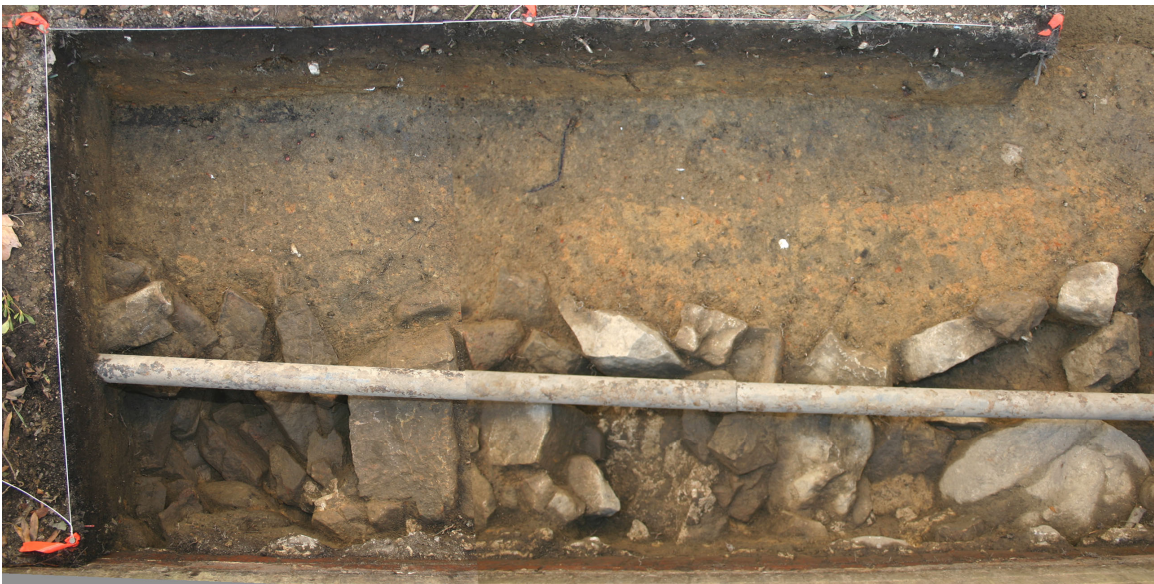
Figure 18. Photographic mosaic of Squares 98R97 and 98R98 after removing disturbed fill above the stone foundation for the south portico. Note the disturbed mottled fill from Utility Trench #1 at the top edge of the photograph. The steel pipe conduit crossing the top of the foundation was placed in Utility Trench #2. North is to the top of photo. Excavation measures 1 m (east-west) by 2 m (north-south).

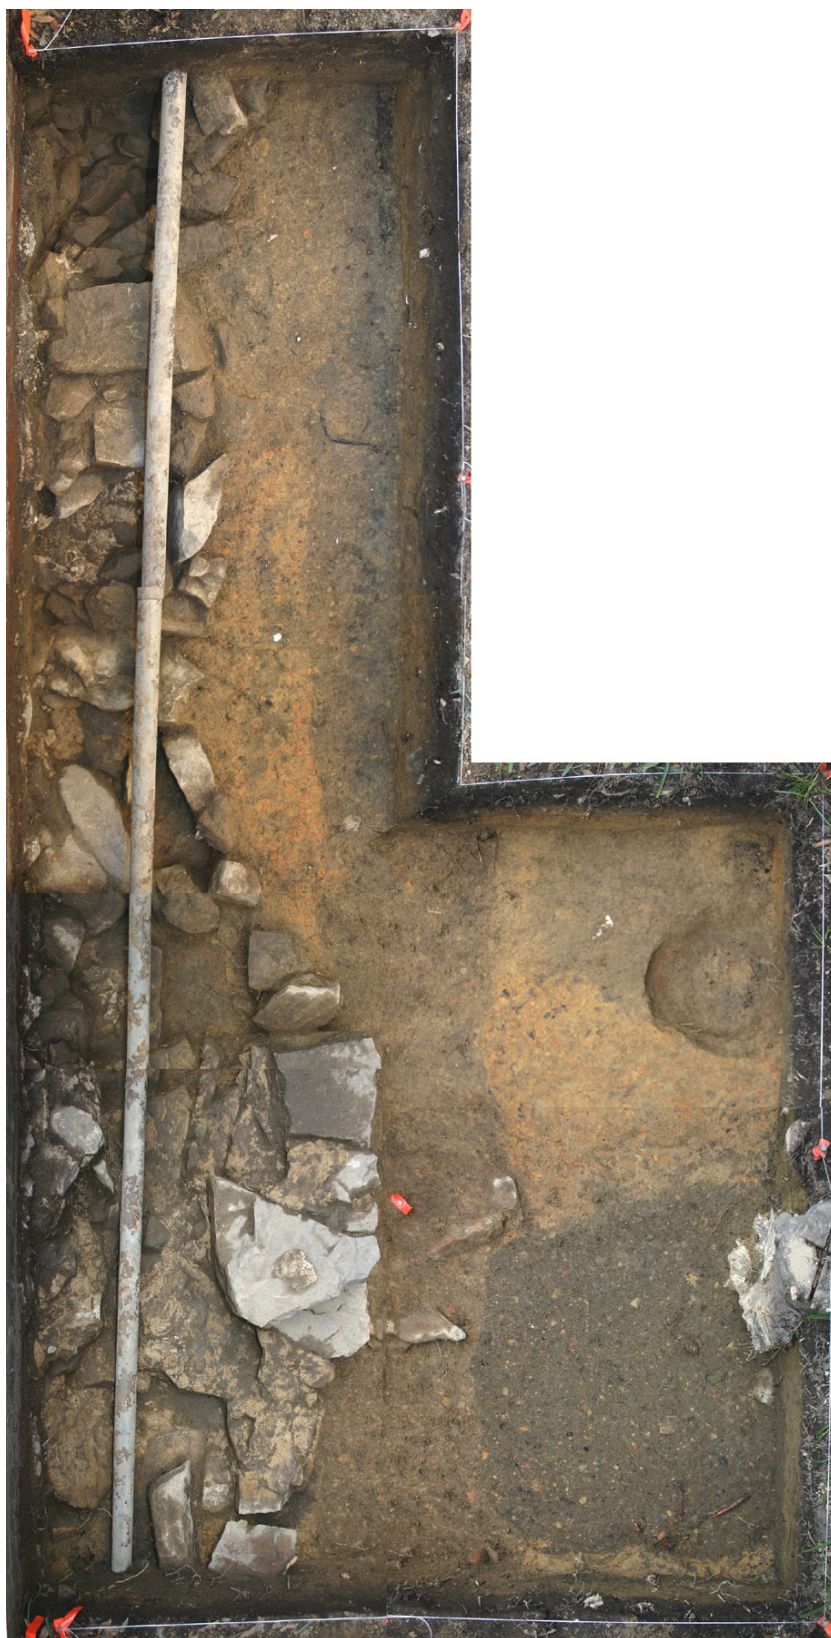
Figure 19. Photographic mosaic of the completed excavation with foundation stones and rubble in place. North is to the right of photo. Excavation measures 4 m (east-west) by 2 m (north-south).

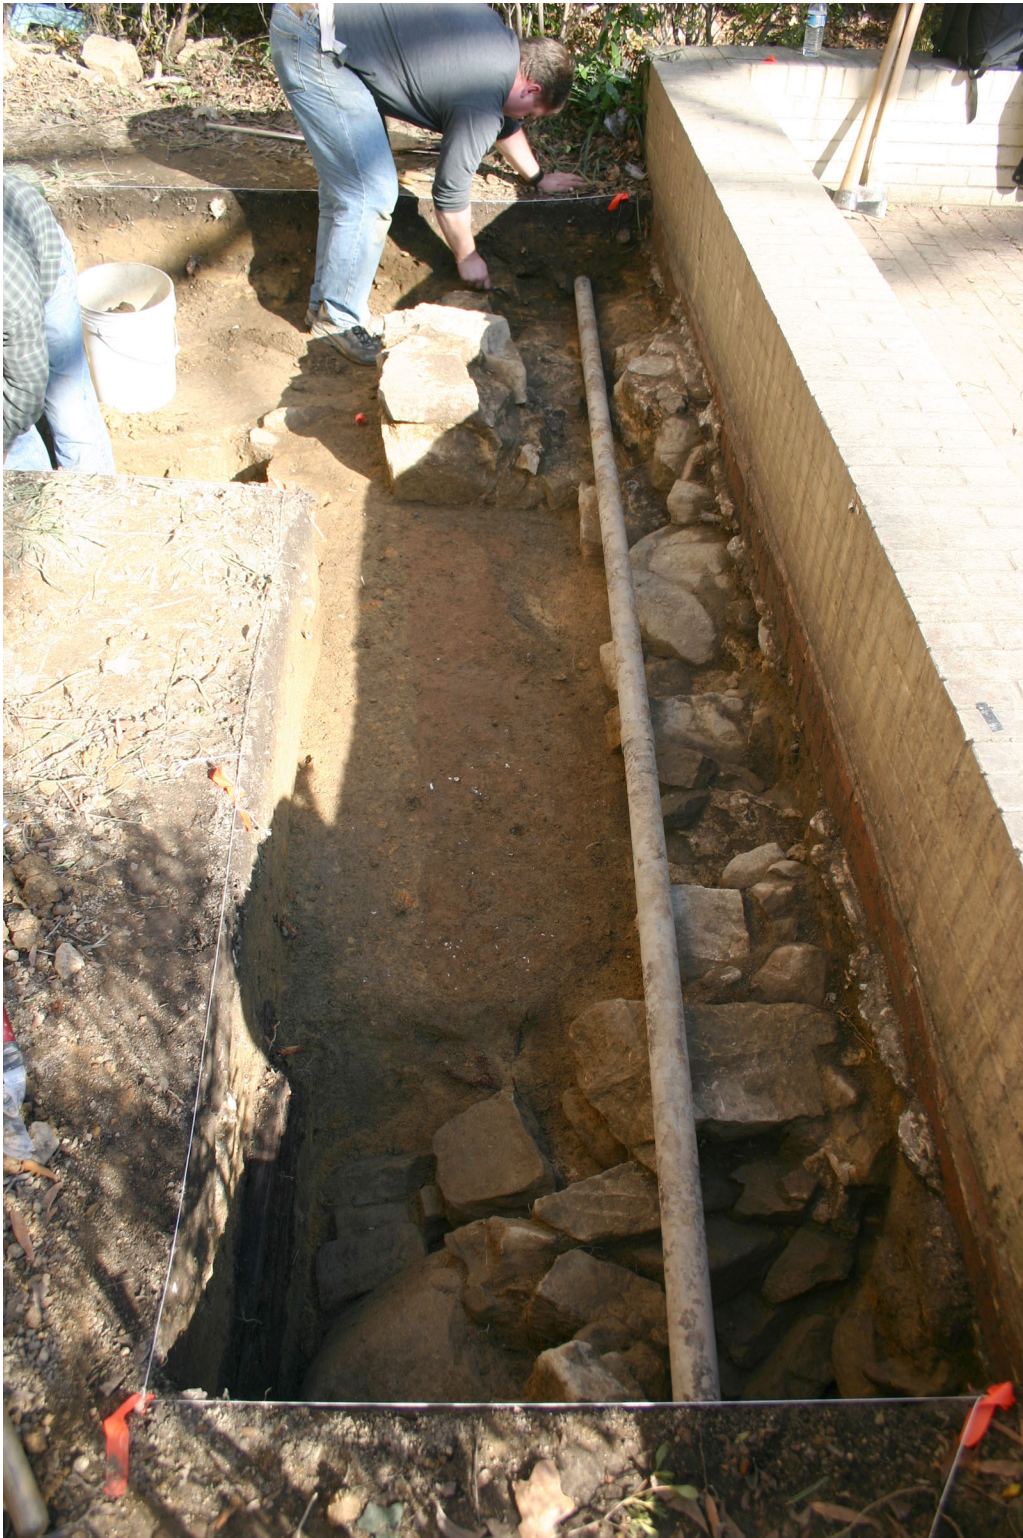
Figure 20. Cleaning the exposed portico foundation. View to east.

Once Squares 98R97 and 98R98 were completed, the entire exposed foundation was re-cleaned and all remaining rubble was removed (Figure 20). At the west end of the excavation, disturbed mottled fill associated with Utility Trench #1 was removed in order to expose the basal stones of the foundation that supported the interior column adjacent to the southeast corner column (Figure 21). This phase of cleaning revealed the original configuration of the portico's foundation (Figure 22).

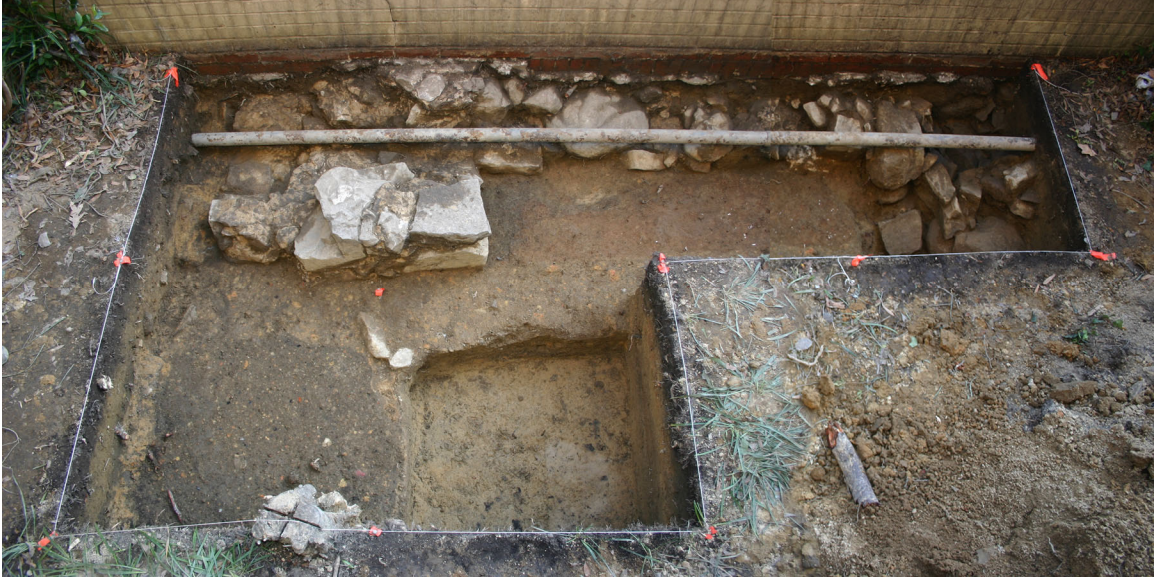
Figure 21. Composite photograph of the completed excavation, showing the southeast corner column foundation (at left) and the adjacent interior column foundation (at right). View to the south.

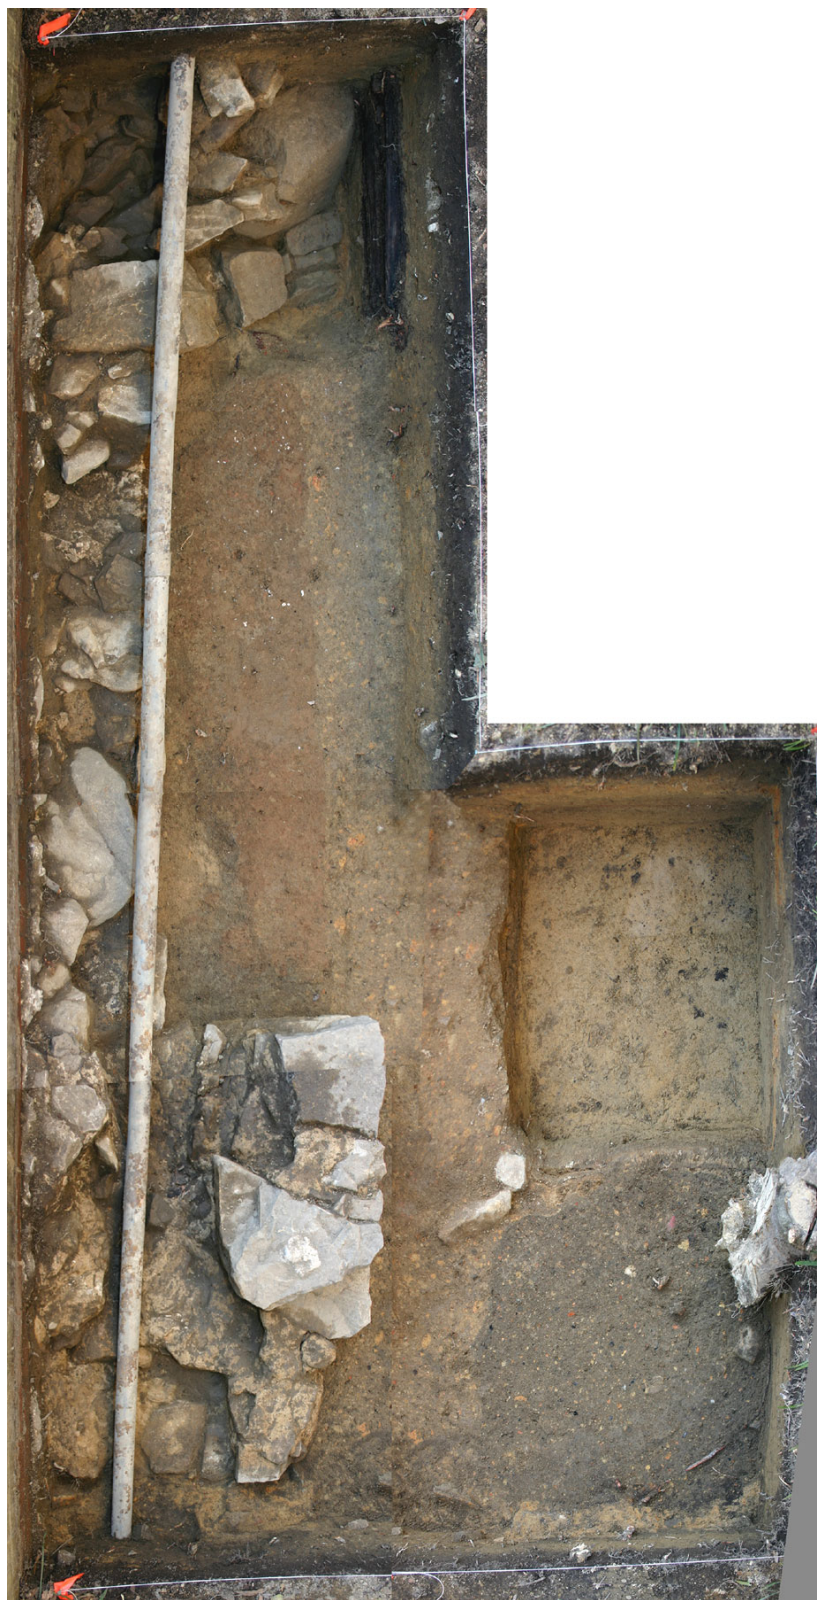
Figure 22. Photographic mosaic of the completed excavation and portico foundation with rubble removed, but prior to removing the base (Zone 3) of Feature 1 (at lower right). North is to the right of photo. Excavation measures 4 m (east-west) by 2 m (north-south).

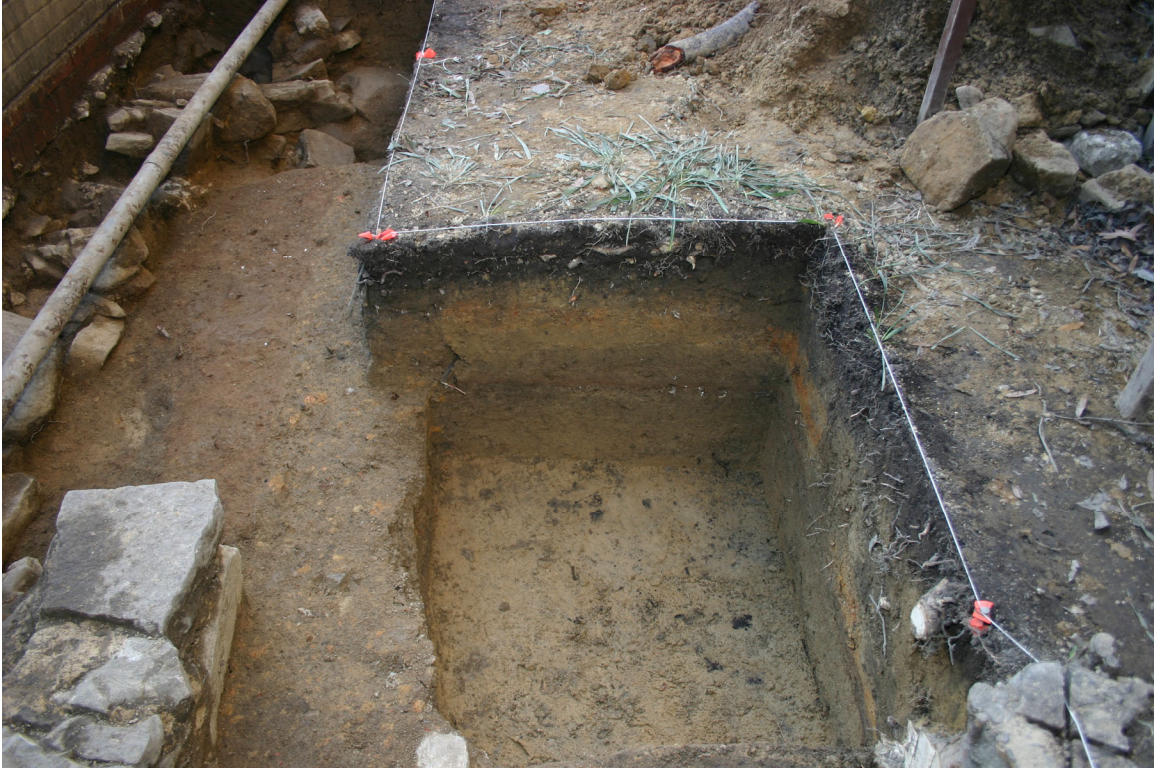
Figure 23. View of the west wall soil profile of Square 99R99, after removing the sand deposit that lay beneath the portico floor.

The mottled lens excavated in Square 99R99 covered a zone of yellowish brown, coarse sandy fill (Figure 23). At the top of this fill were a few small fragments of handmade brick and more numerous fragments of oyster shell. This fill was excavated in two zones, separated from one another by a thin band of reddish brown silt, and all of the fill was screened through ¼-inch mesh. Although about 30 cm of this fill zone was excavated, the artifacts were recovered from only the upper 10–15 cm. Excavation was terminated about 5–10 cm above the top of sandy clay subsoil (as indicated by probing with a soil auger).

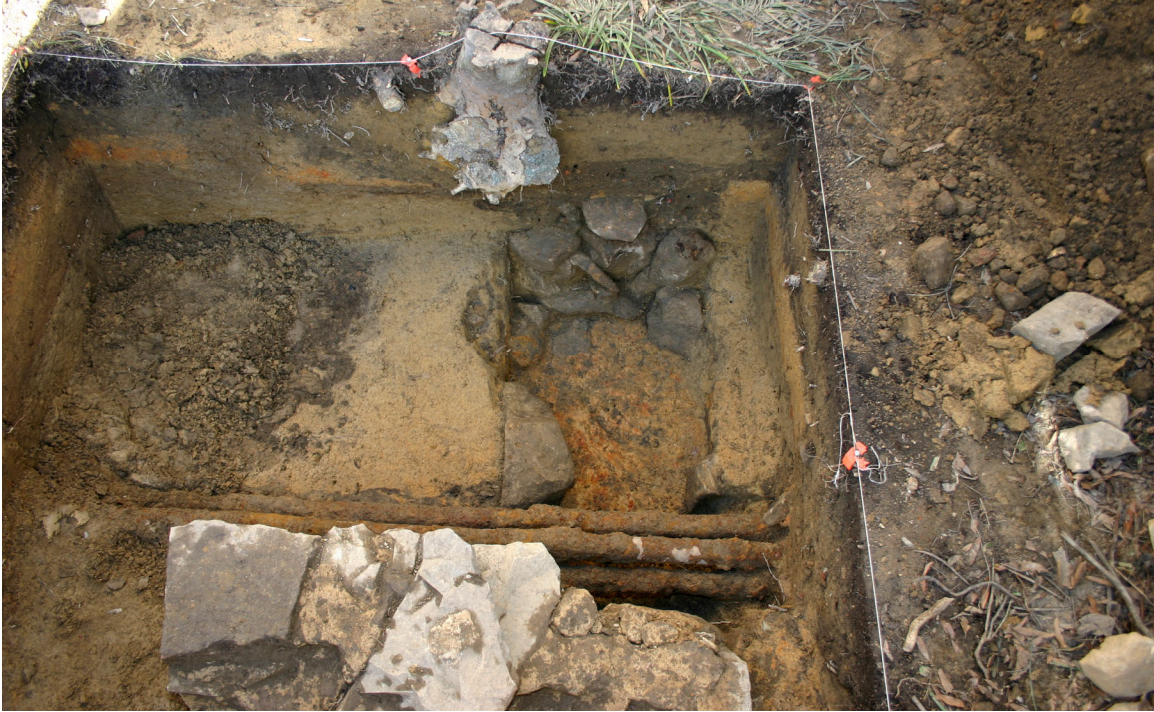
Figure 25. View of Square 99R100, with the builder's trench fully exposed after removing Feature 1. The trench is 61 cm (2 ft) wide and was dug to a stiff clay at 85 cm below surface. North is to the top of photo.

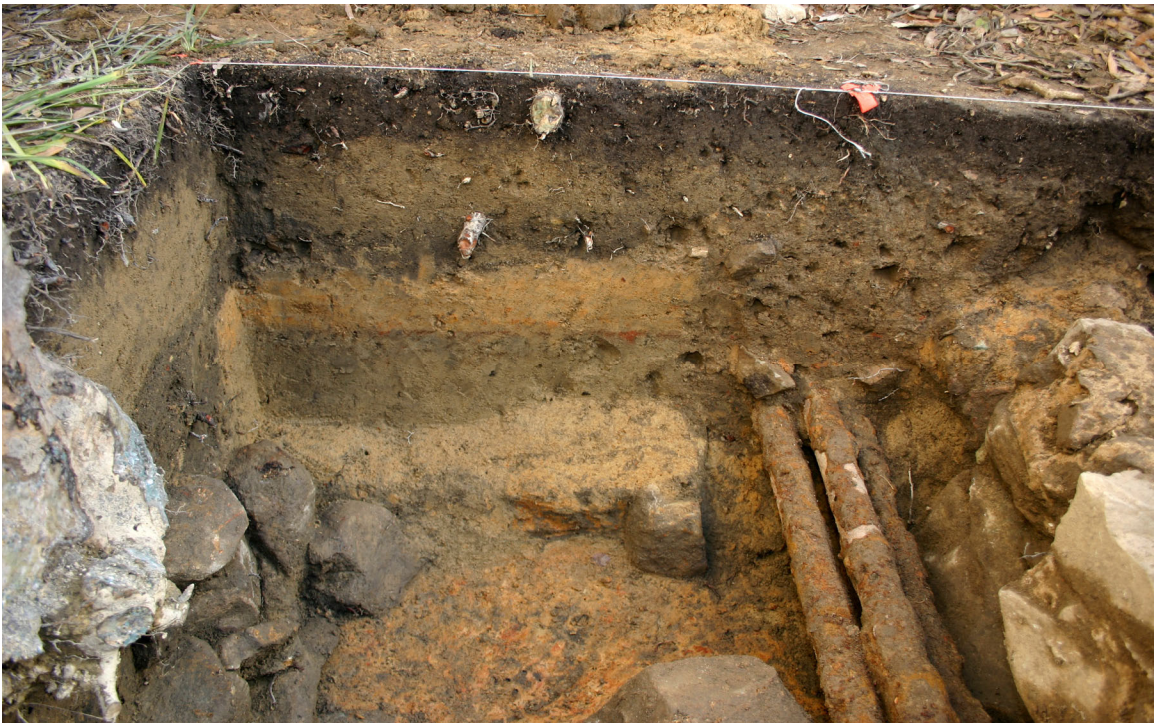
Figure 26. View of the east wall profile in Square 99R100, after exposing the builder's trench. The trench was dug through a sandy loam and into stiff subsoil clay. The overlying clayey fill appears to represent spoil dirt from the original trench excavation. Note the intrusion of Utility Trench #1 and the three exposed pipes containing telephone lines (at right). North is to the left of photo.

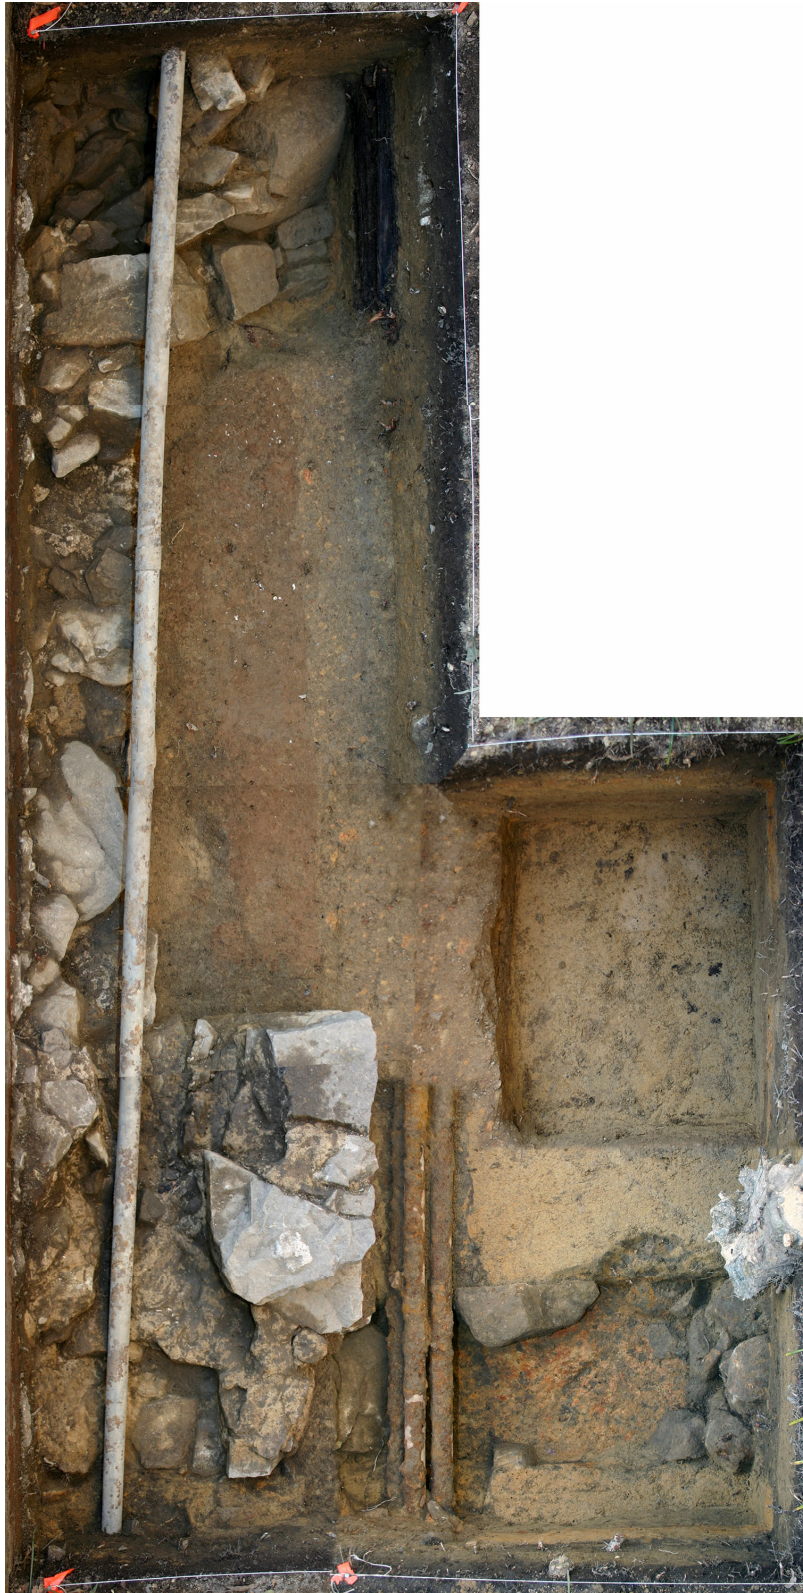
Figure 27. Photographic mosaic of the completed excavation and portico foundation with rubble and Feature 1 removed. Note the builder's trench (lower right) with only a few remaining foundation stones. North is to the right of photo. Excavation measures 4 m (east-west) by 2 m (north-south).
