An Archaeological Survey and Assessment  
of The Proposed  
Carolina Power and Light Mayo Creek  
Project

Trawick Ward  
Michael Trinkley

Prepared By  
The Research Laboratories of Anthropology  
University of North Carolina  
Chapel Hill

April 1977

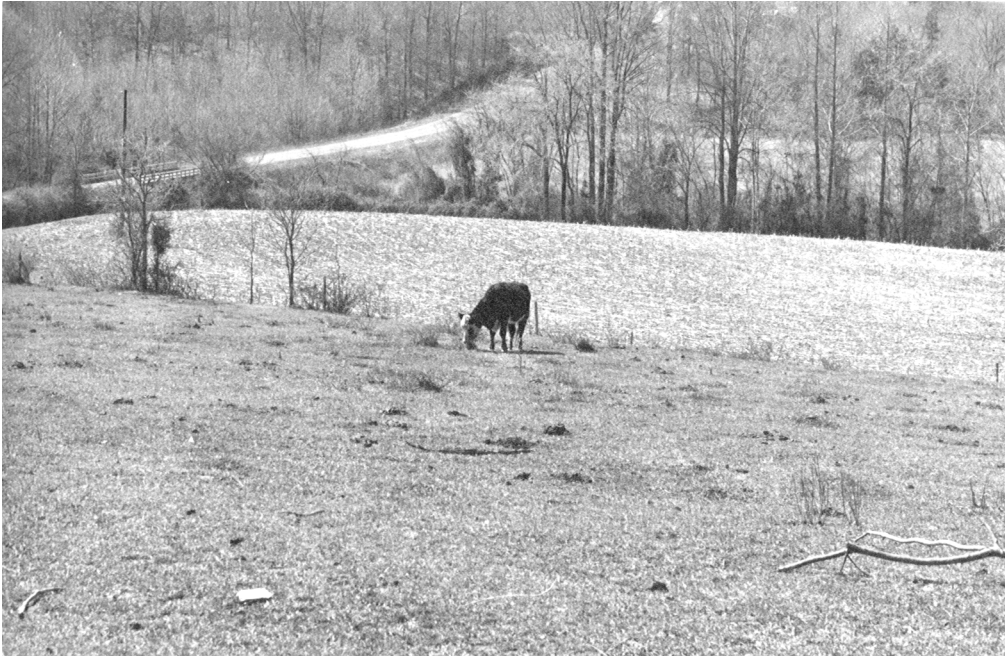
Plate I  
Narrow Flood Plain in the Southern Part of the Reservoir

archaeological data. The zone considered to offer the most productive possibilities was the flood plain along Mayo Creek. It ranged in width from a little over half a mile near the dam site to less than a tenth of a mile in the southern reaches of the impoundment area (Plates I & II). The broad flat fields lying along both sides of SR 1501 in the northern part of the reservoir were considered to offer a very high probability for concealing intact prehistoric cultural deposits (Plate II). On the other hand, the narrow, sometimes swampy, bands of alluvium south of SR 1512 were assigned a much lower probability (Plate I).

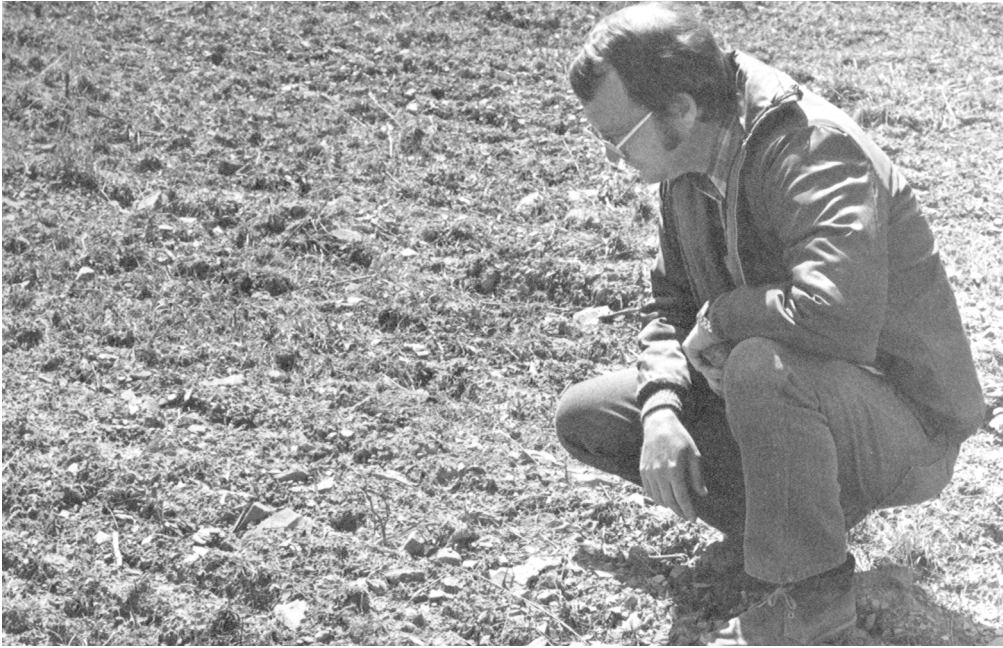
Plate III  
Rocky Soils Typical of Bluff Tops

These soils, with the exception of the Congaree Series, were formed from the underlying rocks, generally fine-textured slates. As a result, the original soils were high in silt content. Today there are numerous changes as a result of surface configuration and rainfall. Erosion and gullying is common, changing not only surface features, but also the texture of the soil (Jurney, Bacon, and Morgan 1928:31). The top soil (A horizon), a sandier, siltier material, is gone, exposing the underlying heavier material of the B horizon. Thus, most of the cultivated soil today is rocky, with the plowing exposing more of the underlying decomposed slates and quartz (Plate III).

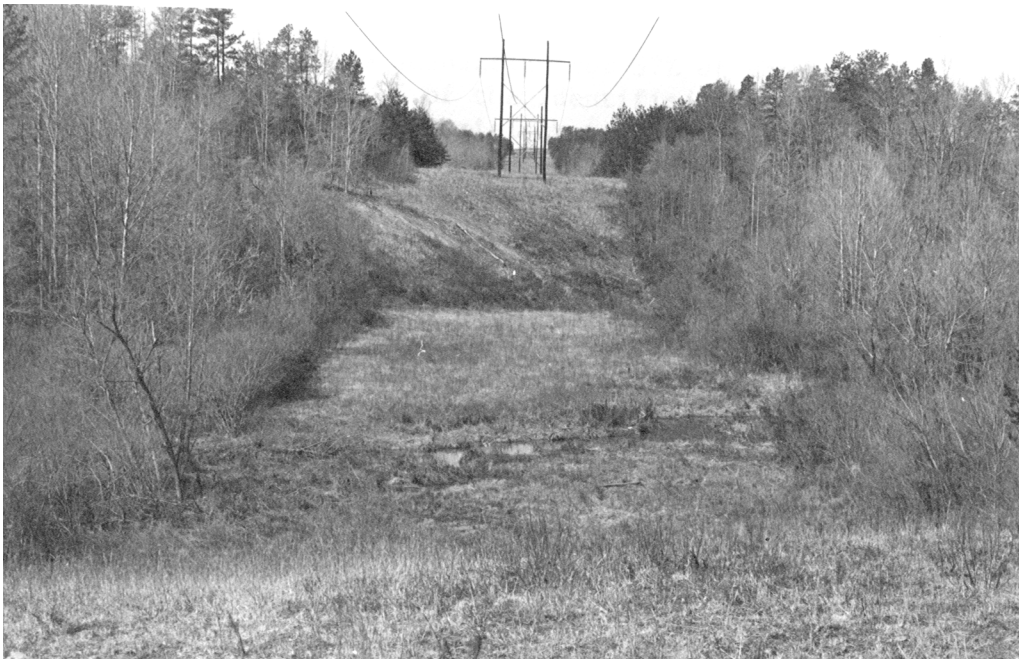
Plate IV  
Vegetation Typical of Survey Area

The extant vegetation of the survey area is oak-pine-hickory, and the area belongs to the Oak-Pine forest region (Braun 1950, Kuchler 1964) (Plate IV). This area is transitional between the Oak-Hickory region and the Southern Evergreen forest region, but was apparently dominated by oaks and hickories in pre-contact times (Braun 1950). The pines persist from an earlier successional stage on poorer soils, and in drier sites. The large number of pines in the Piedmont today is a result of the extensive clearing; pines are usually the first invaders of abandoned fields. Forest succession may also have direct impact on prehistoric settlement

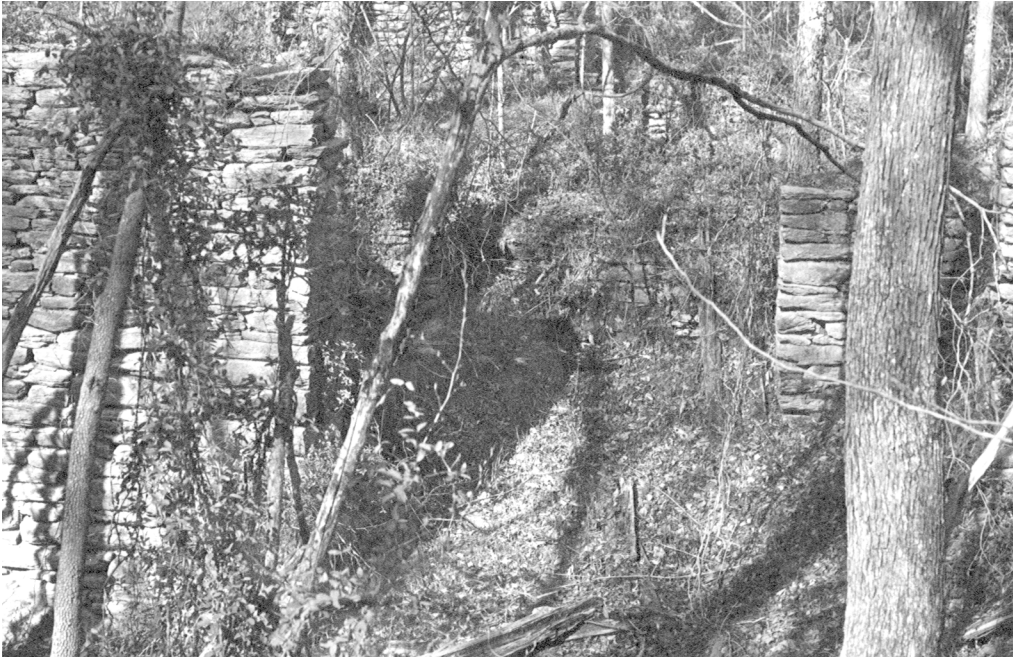
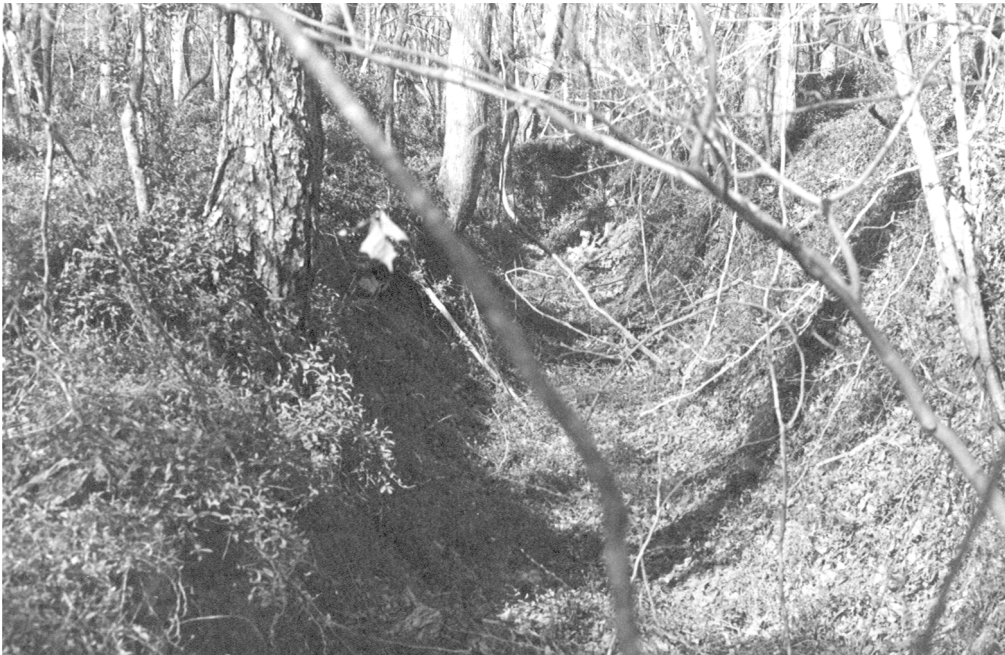
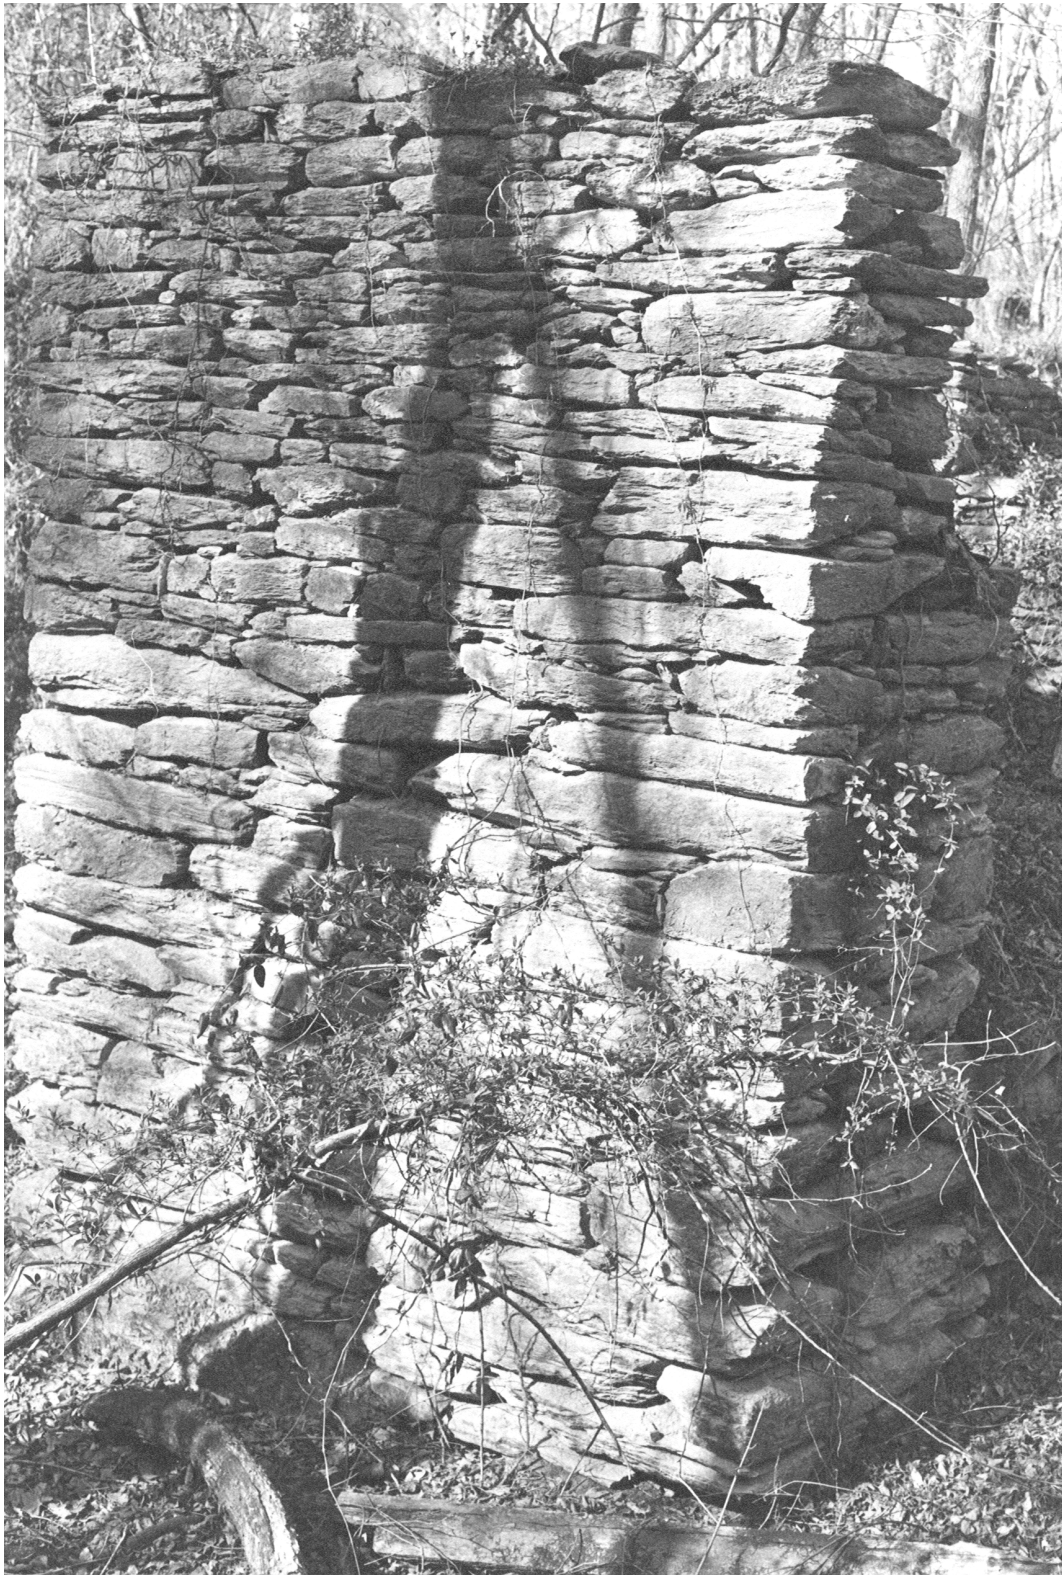
Pr<sup>h</sup>21. This was perhaps the most significant site discovered during the course of the survey. It was represented by the remains of an old grist mill, the Davis Mill, located on the east bank of Mayo Creek, west-southwest of Pr<sup>h</sup>10. Old Davis Mill Road approaches the site from the opposite side of the creek and today is hardly more than an erosional trace. Structural remains included a stone dry-wall foundation some 60' square and a mill race approximately 300' long (Plates V, VI, VII). No artifacts were found associated with the structure, but it appears to have been in use during the latter part of the nineteenth century.

Plate V  
Pr<sup>h</sup>21, Mill Foundation

Plate VI  
Pr<sup>h</sup>21, Mill Race

Plate VII  
Pr<sup>h</sup>21, Close Up of Foundation Wall

Except for the mill site, the six historic sites either lie outside the impact zones, or have little historical significance, e.g. Pr<sup>h</sup>9, 10, 12. Although mitigation is not recommended in the case of the old mill, additional historical research should be undertaken in order to ascertain its role in the development and history of the Mayo Creek communities.

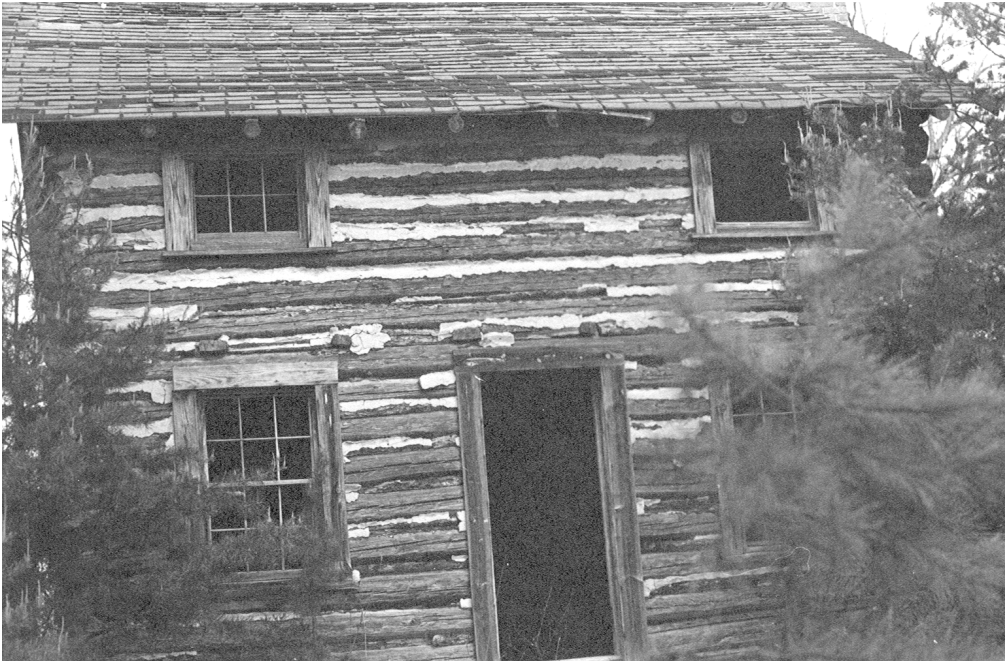
Plate VIII  
Front View of Pr<sup>h</sup>23

Pr<sup>h</sup>23. This site, a hand-hewed two-story log structure, was located on the north side of SR 1512 on a bluff just above the reservoir pool (Plate VIII). Although the roof, part of the chimney, and the exterior facade of the fireplace were modern, the remaining structural elements dated at least to the latter part of the last century (Plate IX).

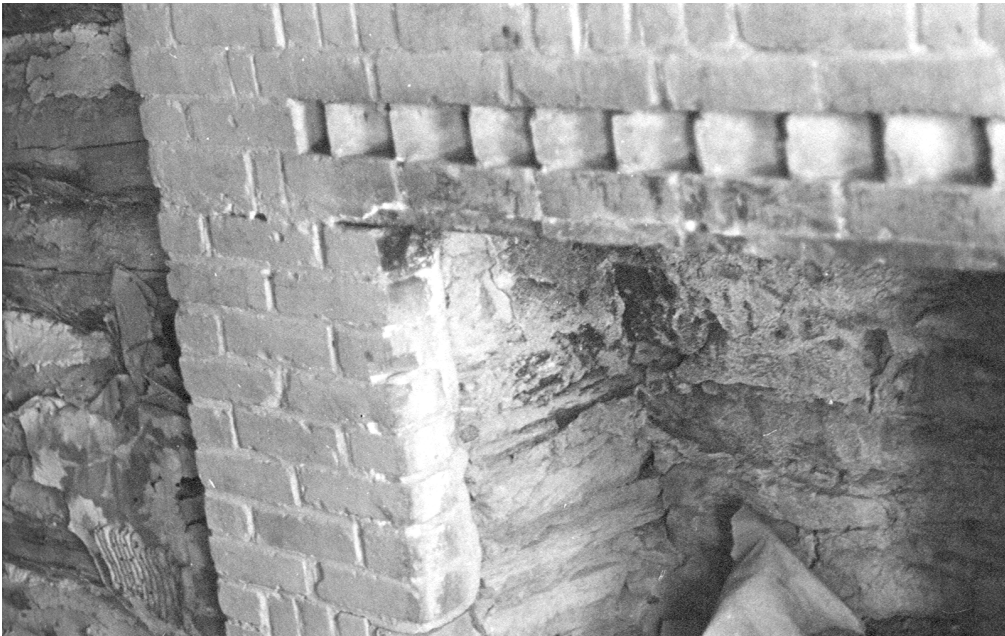
Plate IX  
Fireplace in Pr<sup>h</sup>23, Note Modern Facade
