**AN ARCHAEOLOGICAL AND HISTORICAL INVESTIGATION
OF THE BATTLE PARK PAVILION SITE (31OR639)
ON THE CAMPUS OF THE UNIVERSITY OF
NORTH CAROLINA AT CHAPEL HILL**

**R. P. Stephen Davis, Jr.
Principal Investigator**

Research Report No. 35
Research Laboratories of Archaeology
University of North Carolina at Chapel Hill

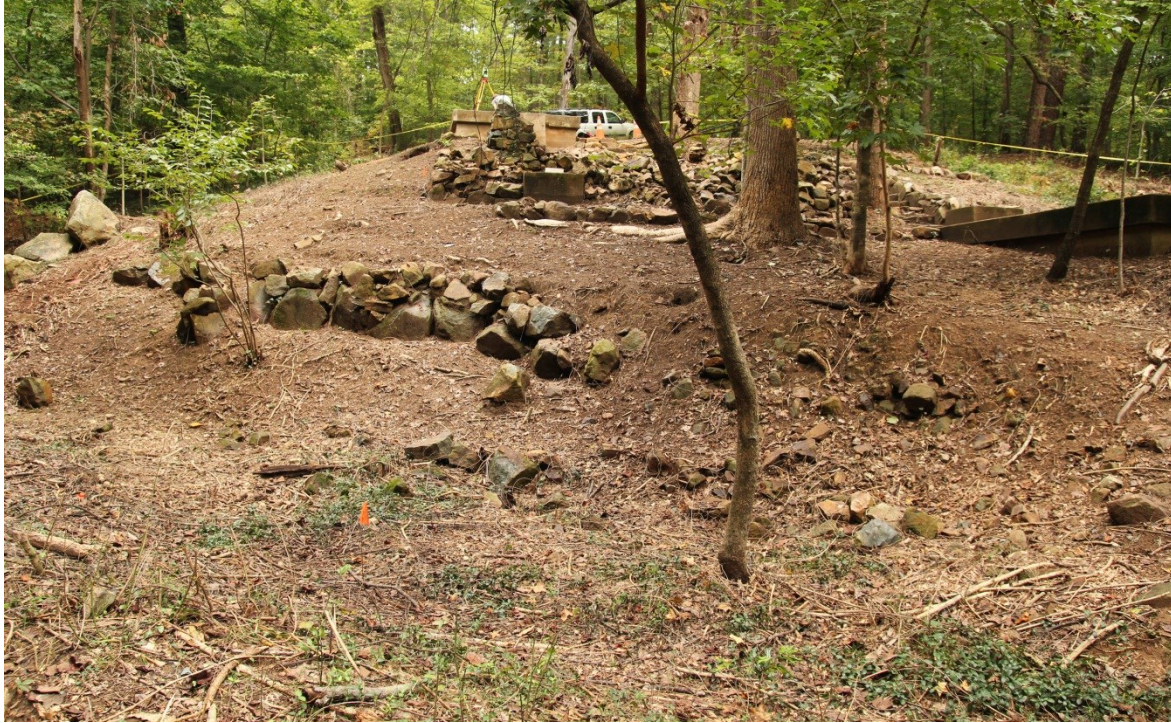
Figure 4. View of Component 2. The stacked stone retaining wall and northern edge of the sludge bed runs midway across the image. Halfway across from the left, the wall is collapsed into the sludge bed basin. Photograph taken from bank of Battle Branch Creek, facing north.

Roughly parallel to the creek bank, a rectangular depression accentuated by what appeared to be foundation ruins was noted and designated as a possible building (Figures 4 and 5). The northern foundation was the most intact and looked as if it were a naturally retrofitted

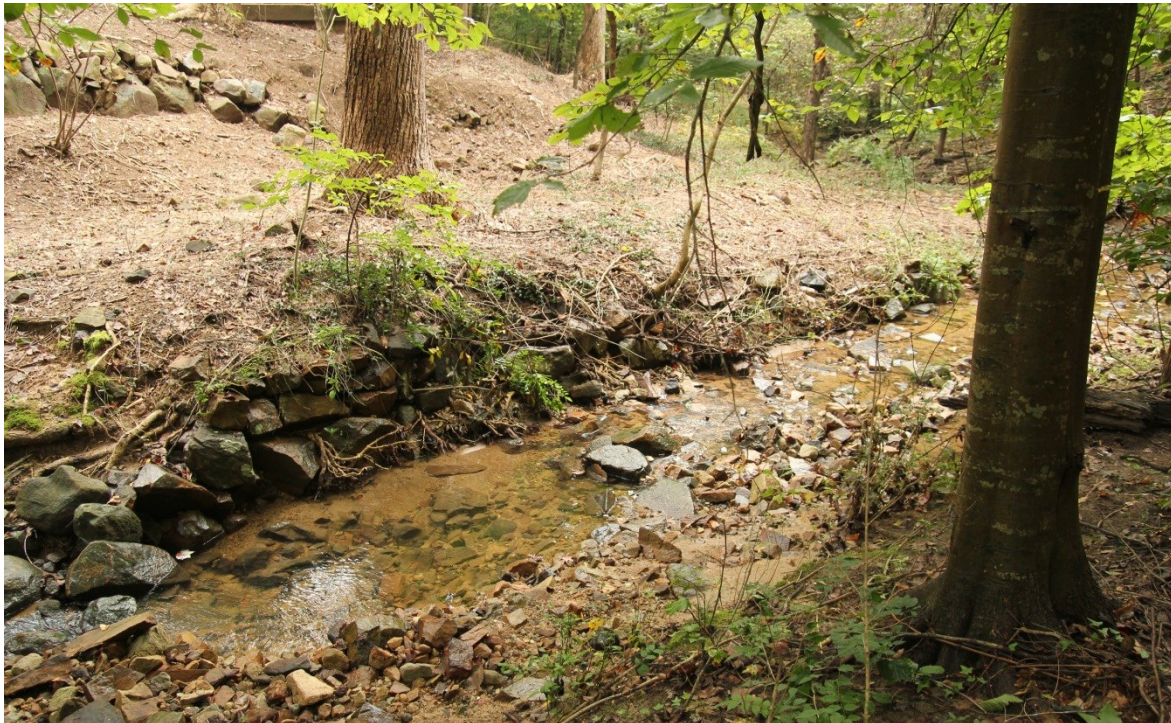
Figure 5. View of Component 2. Partially intact stacked stone retaining wall present in the bank of Battle Branch Creek directly south of sludge bed. Photograph taken from southern bank of creek, facing approximately east.

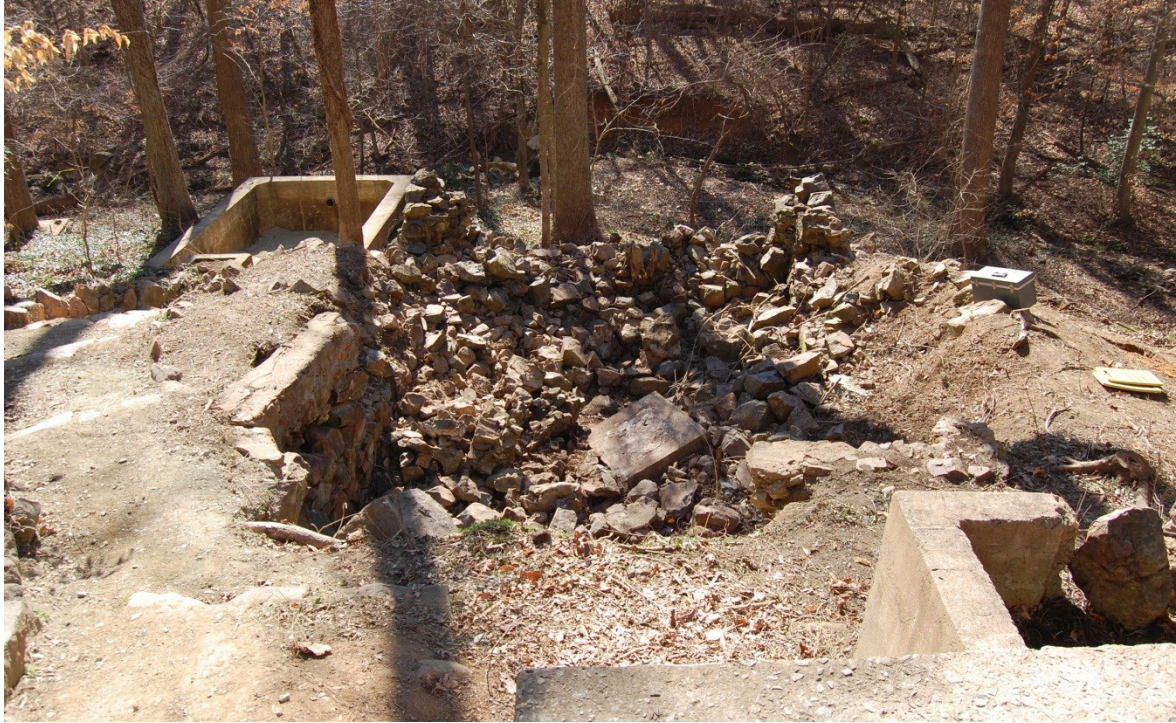
Figure 6. View of Component 3, taken from northern (upper) concrete tank facing south. Photographed in February 2012, prior to removal of the collapsed stone debris overlying the structure's floor. The southern (lower) concrete tank, part of Component 5, is visible in the top left of background.

A partially above-ground, rectangular, dry-laid stone structure, located at the center of the site, was interpreted as a building foundation, most of which had collapsed into its own cellar (Figures 6 and 7). Based on *in situ* corners and edges, the foundation dimensions, measured along the outer edges, are approximately 22.4 ft north-south by 16.6 ft east-west. The cellar floor was filled in and obscured with rock rubble. Sizable slabs of concrete were also present inside the rubble-filled foundation, and these were interpreted as debris that had been tossed in following the plant or pavilion construction episodes. The contrast of the poured concrete structures alongside the dry-laid stone construction suggested that the stone foundation predated the 1920s. And, it was suggested that the stone foundation might post-date Component 2. If the northern wall of the Component 2 structure acted as a barrier, catching upslope sediment runoff, then it would have aided in the formation of the terrace into which the Component 3 foundations and cellar were dug (Davis 2012:2). Further differentiating this structure from other site elements that could be directly attributed to the sewage disposal plant was its obvious deviation from the grid orientation on which the concrete structures were aligned. Further archival research and testing determined that this structure likely was built circa 1920 as a cesspool, and it was subsequently incorporated into the sewage disposal plant and used as a trickling filter.

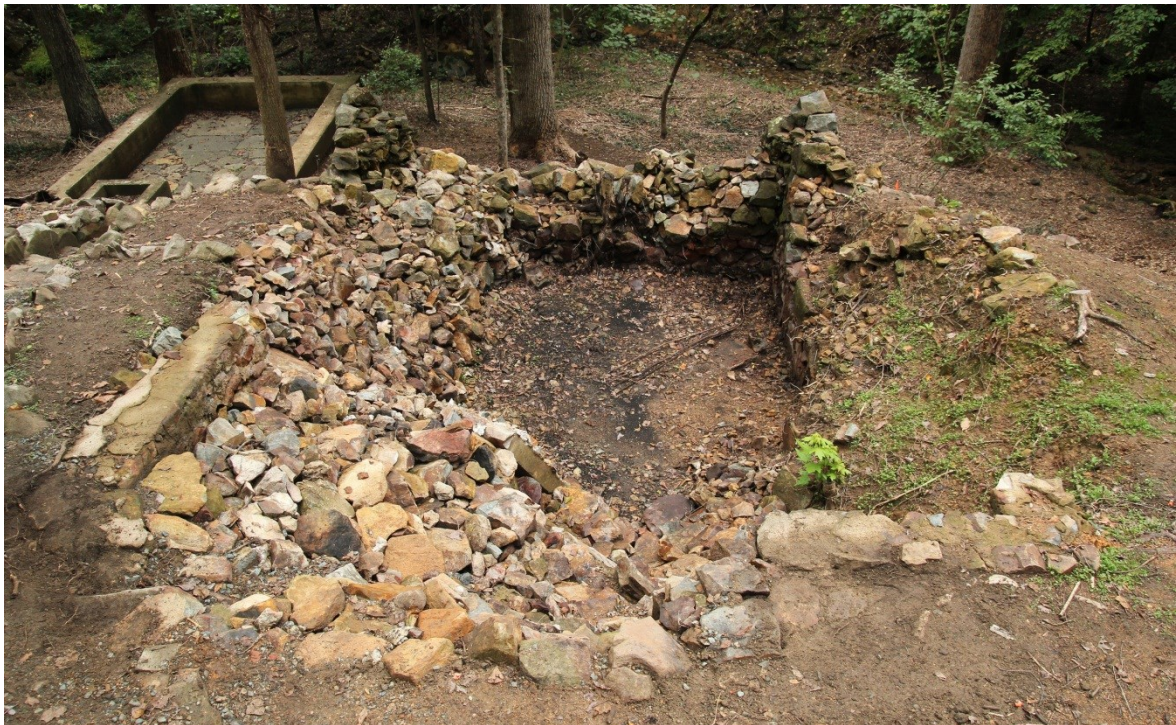
Figure 7. View of Component 3, taken from the northern (upper) concrete tank facing south. Photographed in October 2012, after the removal of the collapsed stone debris overlying the structure's floor. The southern (lower) concrete tank, part of Component 5 and partially filled in with concrete slabs, is visible in the top left of background.

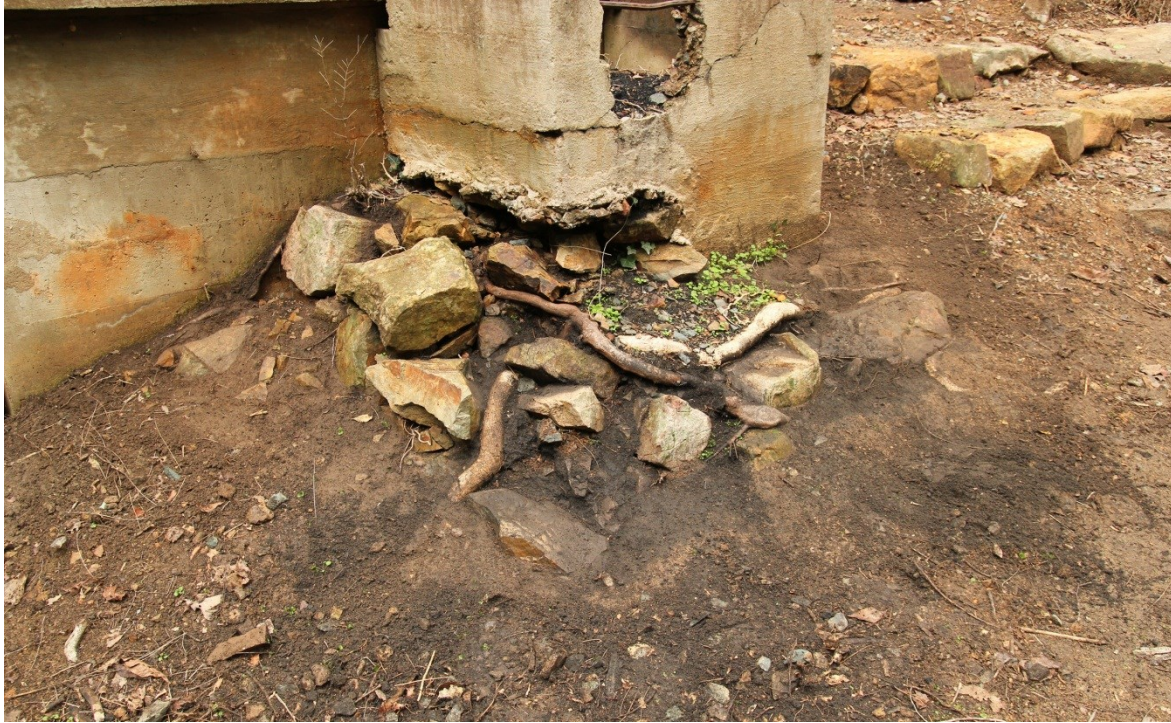
Figure 8. View of the western end of Component 4, lying beneath the small concrete junction box poured against the southern edge of the upper concrete tank (Component 5). View to northeast.

Just north of Component 3, another possible stone foundation remnant was noted. Component 4 is a roughly linear line of exposed rocks, the western end of which appears to corner and run underneath and into poured concrete structures (Figure 8). A small concrete box was poured directly onto this apparent corner, unmistakably defining the construction sequence. Also, the orientation of the linear rock feature was aligned with that of Component 3, suggesting a possible relationship between the two. The presence of a corner, the alignment, and the linear form of the rocks originally gave rise to the idea that this might be another foundation remnant, the majority of which had been destroyed by the construction of the large concrete tank directly to the north.

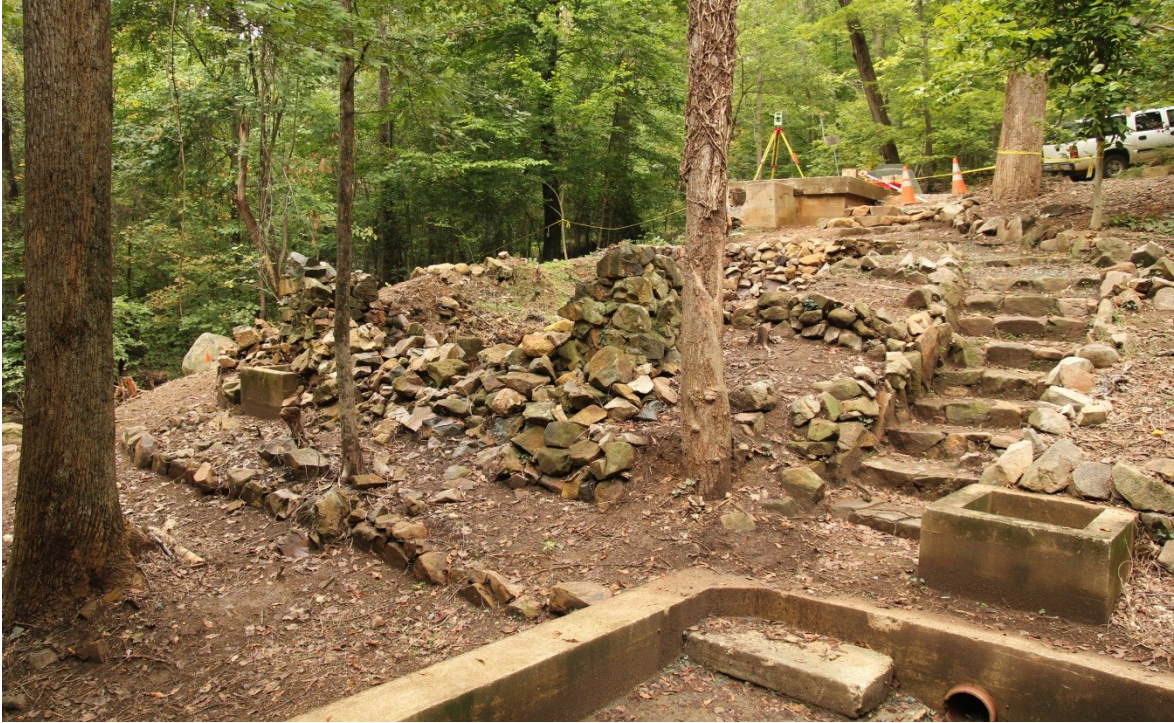
Figure 9. General view of site, facing northwest from the lower concrete tank (foreground). Other Component 5 elements include the small concrete junction boxes (at bottom right and left, adjacent to Component 4 rubble), and the northern (upper) concrete tank with the total station resting atop it.

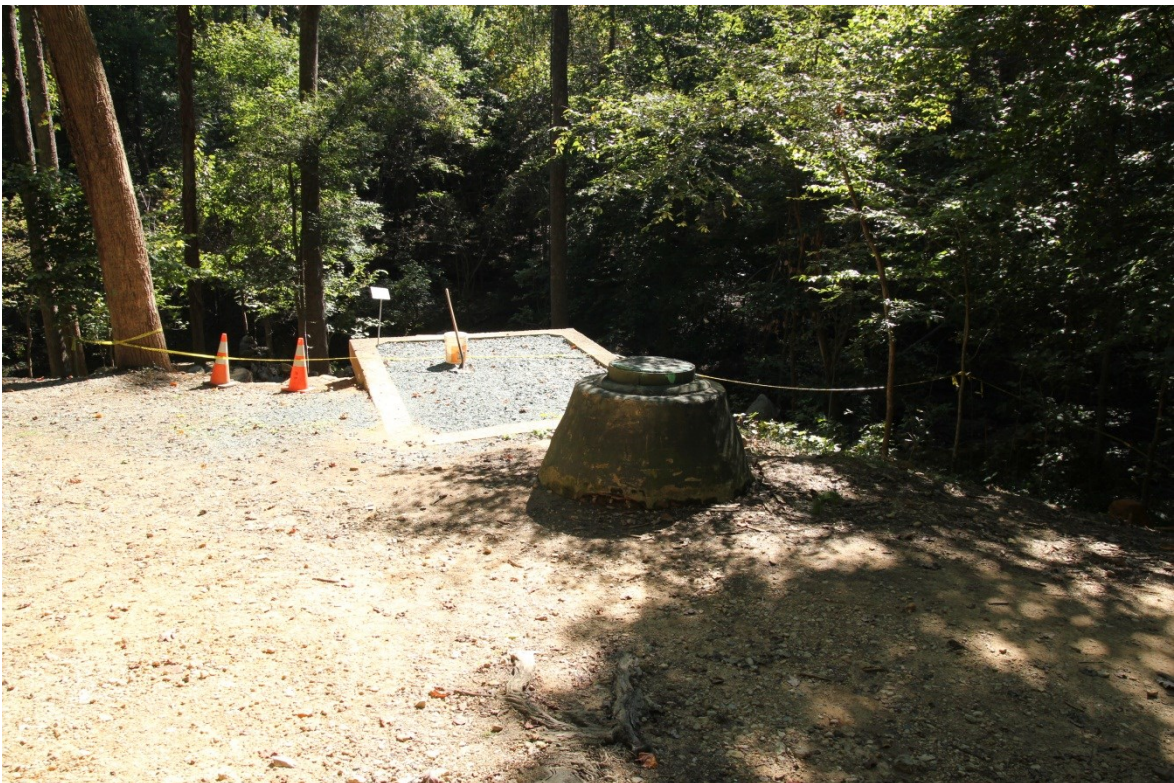
Figure 10. South facing view of the brick-and-concrete manhole and upper concrete tank, both elements of Component 5, at the northern edge of the site.

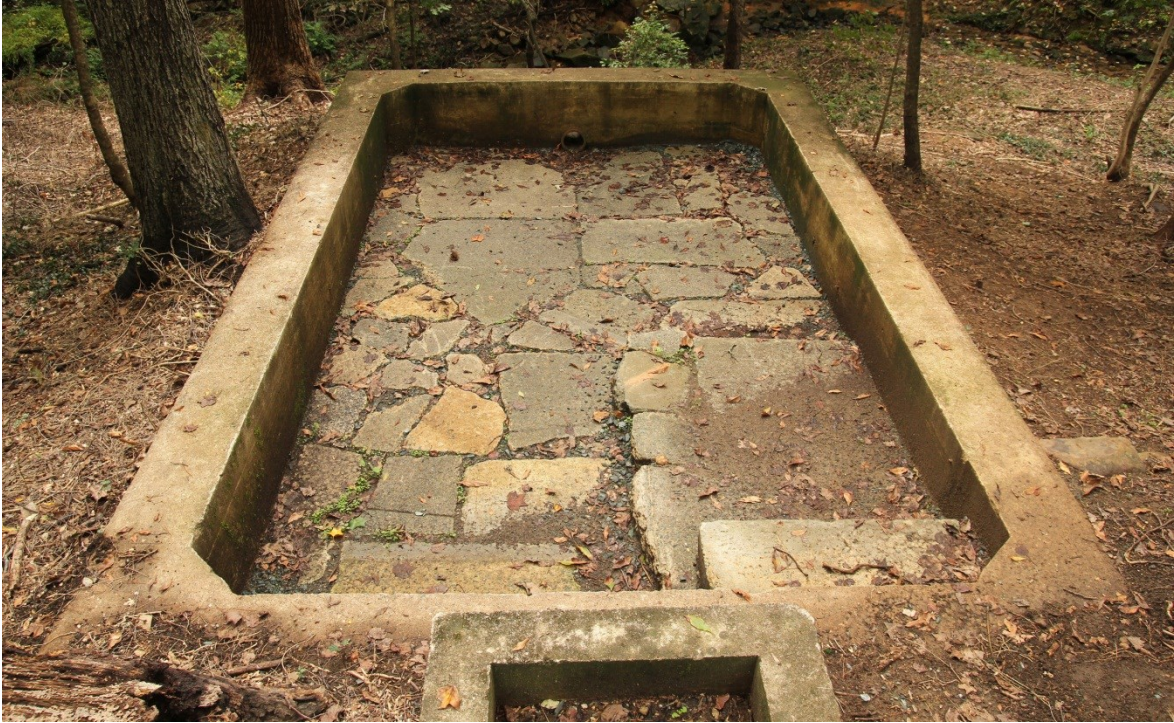
Figure 11. South facing view of southern (lower) concrete tank (Component 5). The small concrete junction box, also part of Component 5, is partially visible at the bottom of the image.

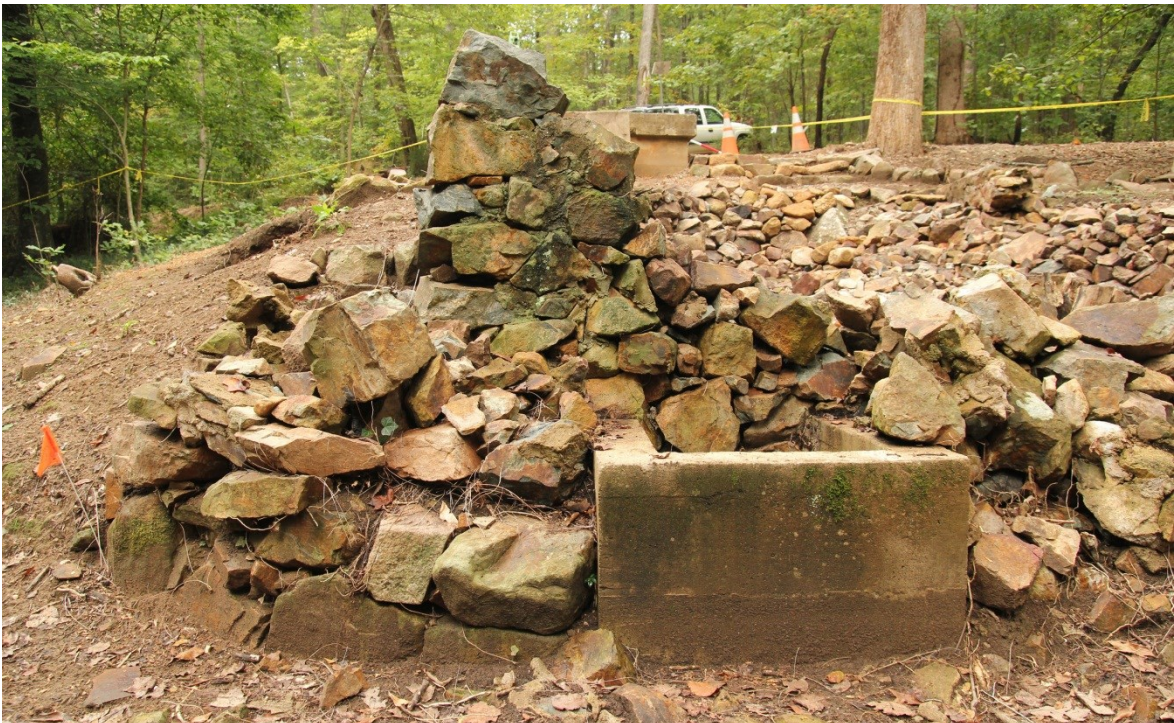
Figure 12. North facing view of the southwestern corner of the large, dry-laid stone structure (Component 4), with a small concrete junction box (Component 5) poured up against its exterior.

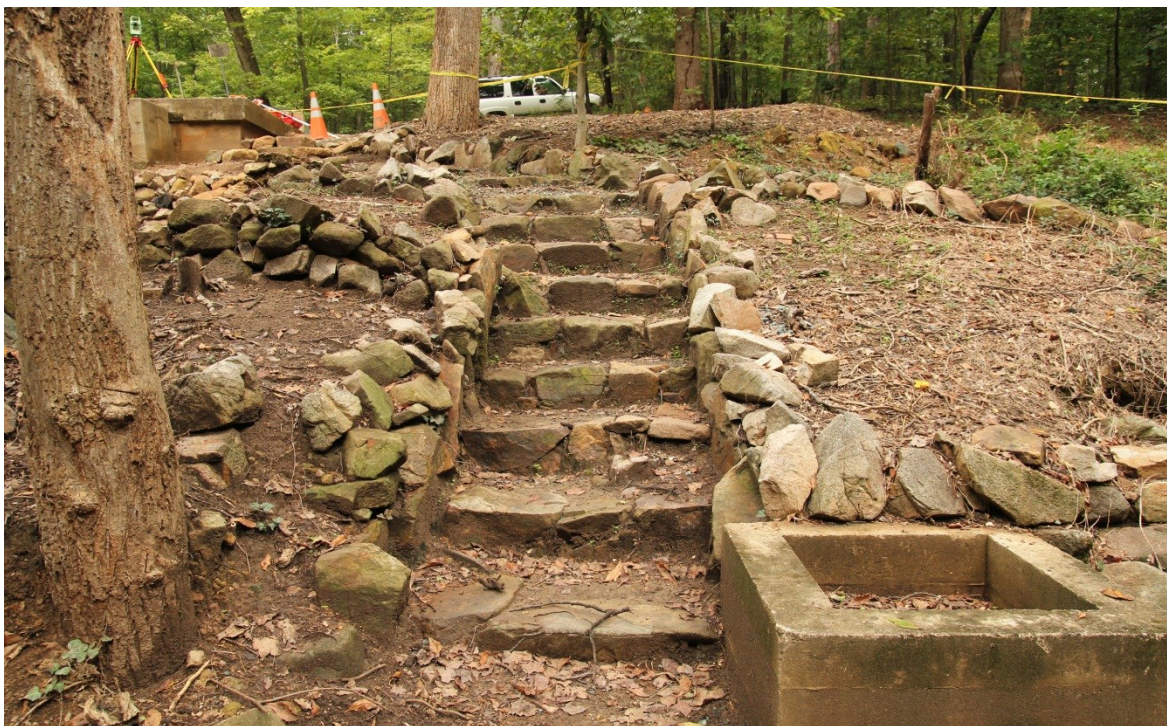
Figure 13. North-facing view of stone steps attributed to the Battle Park Pavilion phase of site use (Component 6). To the left of the steps, stone-lined terraces that abut the central stone structure are visible.

Component 6 was another set of stone structures recognized in part due to the availability of historical information and their practical contrast to the rest of the site features. These include the dry-laid rock steps running roughly parallel to Component 3, the stonework terracing perpendicular to Component 3, and the stone boundary linings of on-site paths (Figure 13).

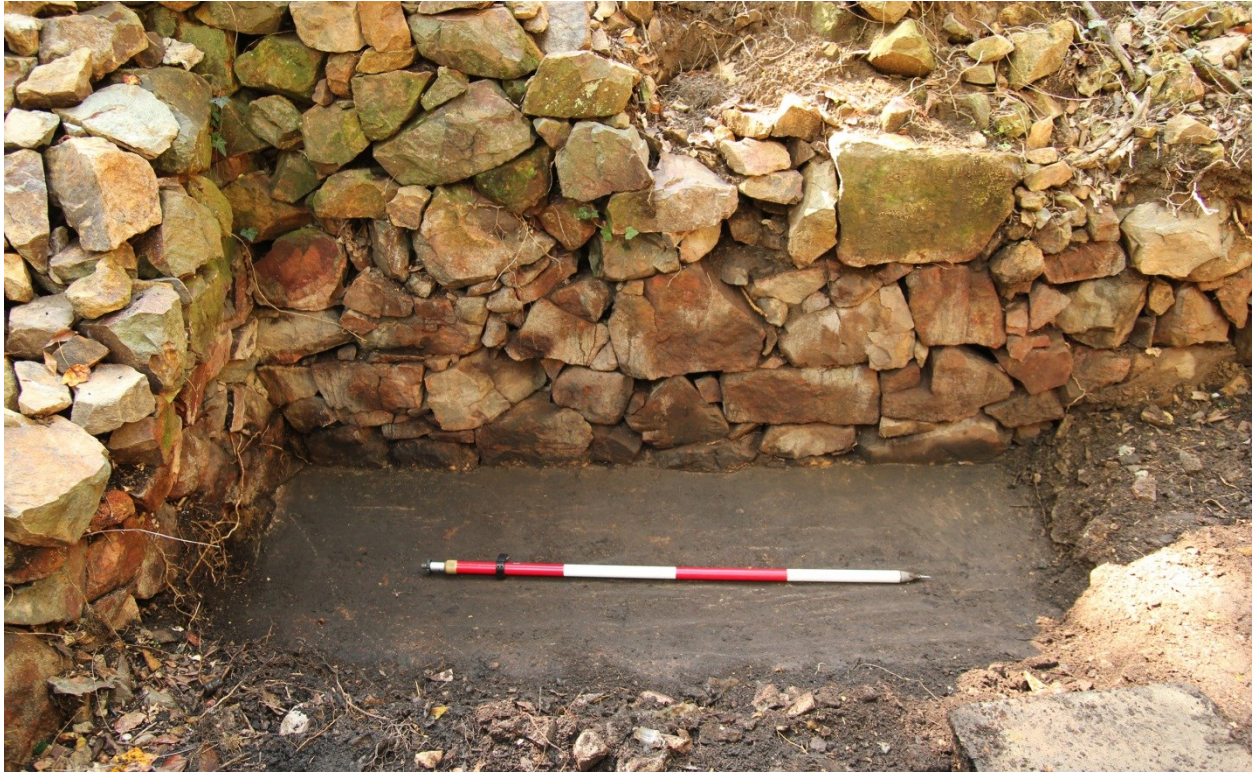
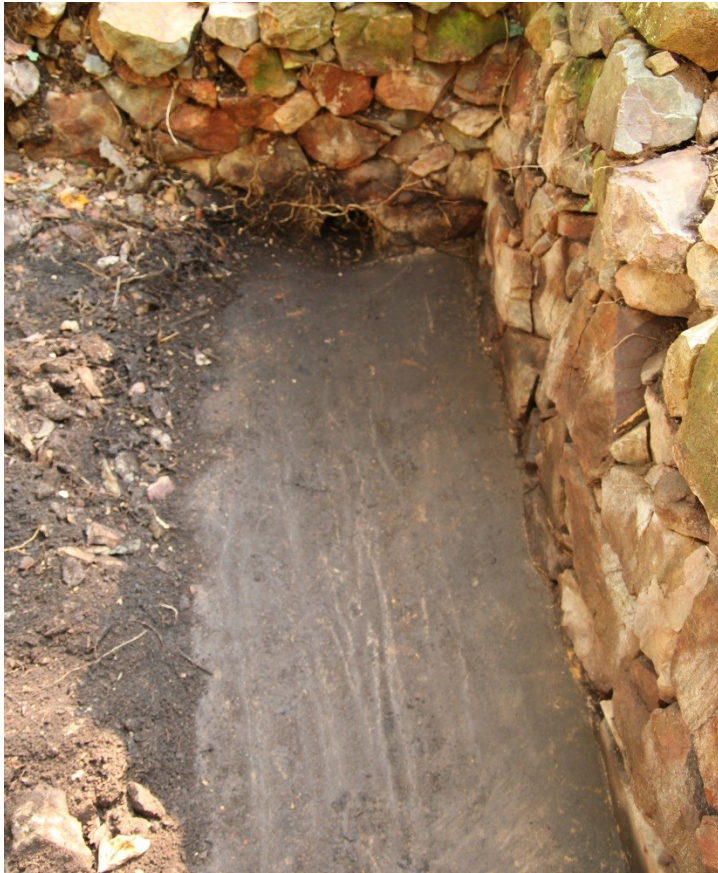
Figure 18. Post-excavation images of the unit in the southwestern corner of the dry-laid stone structure (Component 3).

Top frame shows the concrete floor poured up against the inner rock wall. The view is due west and a prism rod is included for scale.
